# **BUILDING** *FACADE* *MAINTENANCE, REPAIR,* *and INSPECTION*

STP 1444

# ***Building Façade Maintenance, Repair, and Inspection***

## Reporting Unsafe Conditions at Public Schools and Private Structures

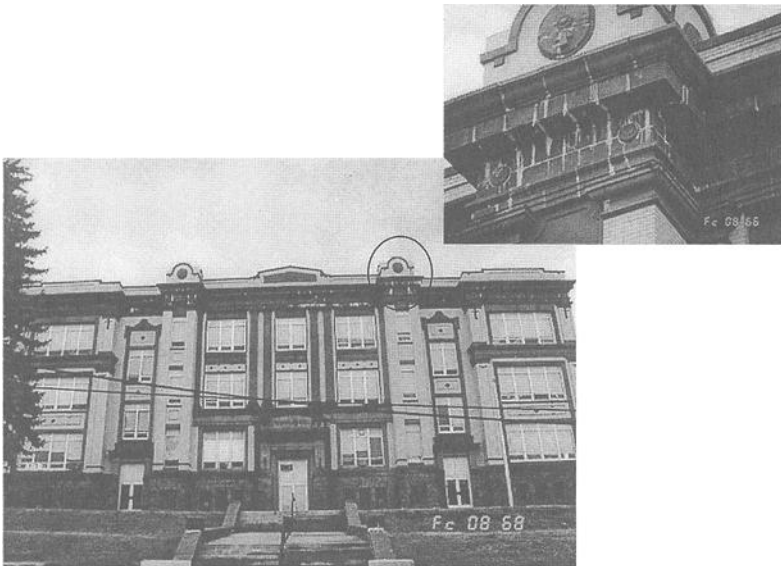
This brick, stone and terra cotta structure was reviewed for the school superintendent, who was alerted by a roofing consultant (contractor) that problems with the structure's masonry parapets might cause problems (Figure 1). After a cursory review by our firm, we recommended that the school district engage a licensed professional architect and civil engineer and immediately construct overhead protection for pedestrians at building entrances and cordon off the remainder of the facility. Within one month of the submission of our report, the structure was abandoned and later condemned.

Figure1 – *Northeastern Pennsylvania Middle School*

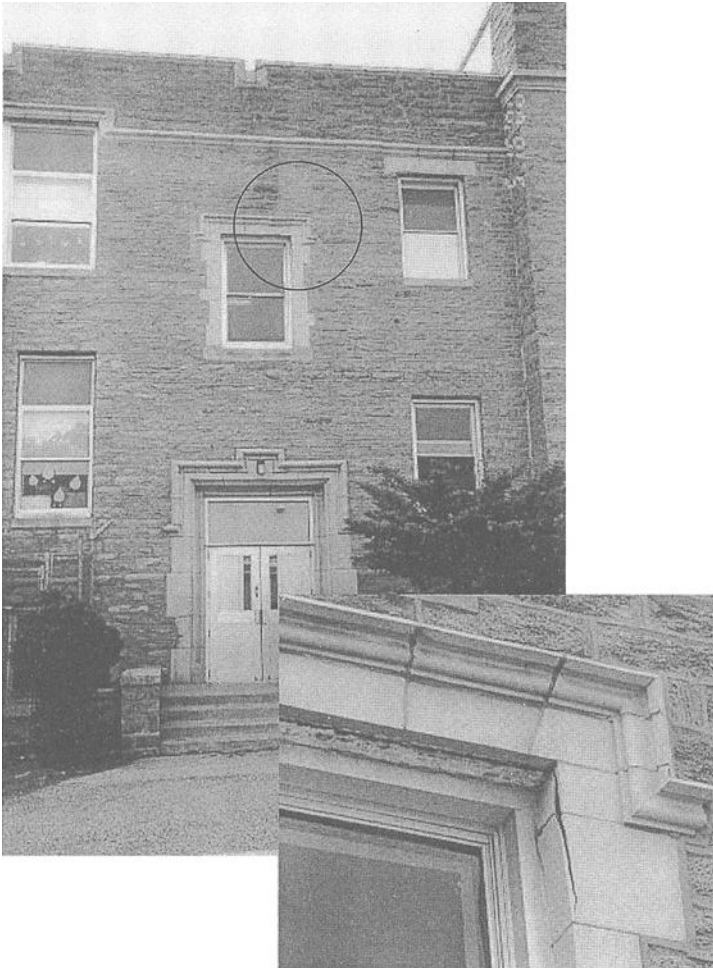
We were requested by the school district's attorney to inspect cracks in this structure's stone parapets. Our cursory review identified incipient terra cotta spalls which posed an immediate life safety concern (Figure 2). A licensed civil engineering firm was quickly engaged to inspect the façade and protective netting was installed prior to the next school year. Currently, the facility is being refurbished, including an extensive repair/preservation program to address masonry envelope deficiencies.

Figure 2 – Southeastern Pennsylvania Grade School

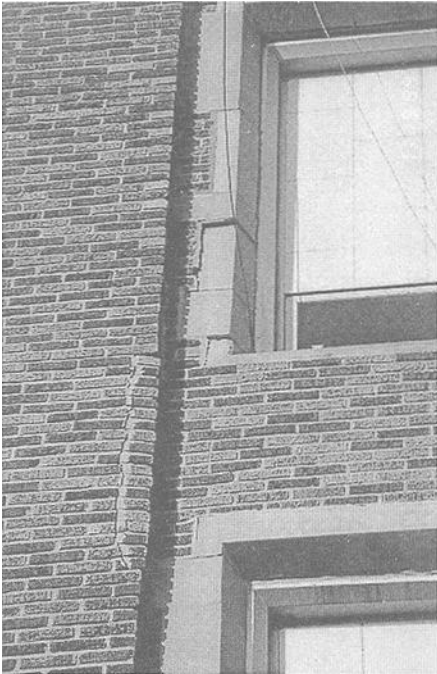
Two school structures were informally reviewed for the district’s architect. The brick and limestone facility (Figure 3) exhibited severe wall displacement caused by oxide jacking and a brick and terra cotta structure (Figure 4) exhibited widespread incipient terra cotta spalling. After expressing our concerns regarding these structures, the architect was hesitant to forcefully react to the identified deficiencies. To fulfill our ethical obligation, the State Department of Education was independently notified with regard to the structure’s condition.

All of the projects listed above were mass masonry structures constructed during the early twentieth century. The primary cause of deterioration was the corrosion of embedded steel anchors and supports caused by a general lack of good preventative maintenance. These facades were allowed to deteriorate to a point where their occupants, school children and the public, were needlessly exposed to unsafe conditions.

Figure 3 – *East Central Pennsylvania*

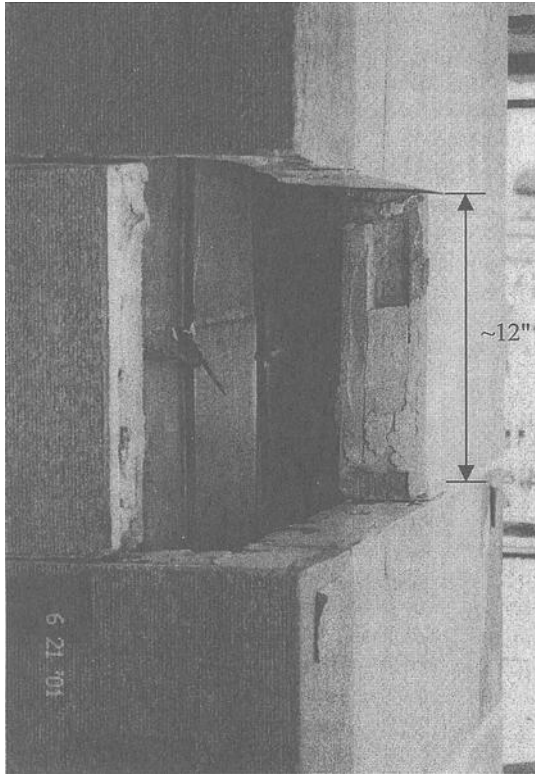
Figure 2 – Removal of a whole terra cotta unit to reveal substrate conditions

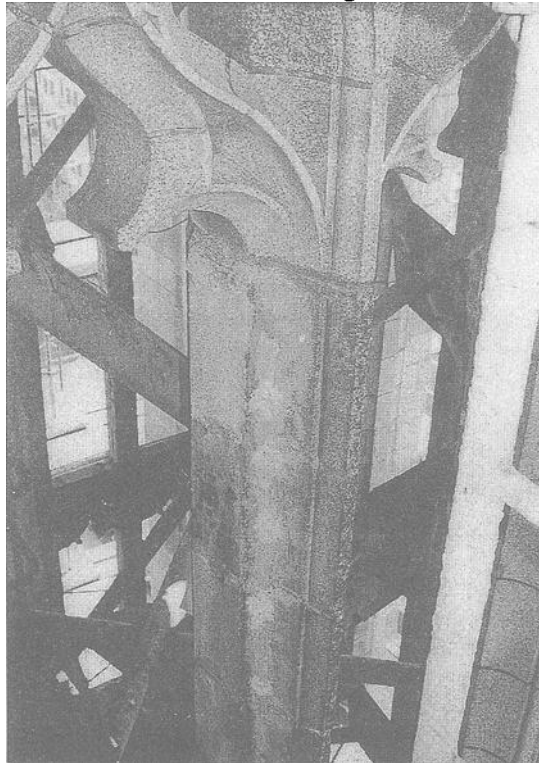
*Replacement of Deteriorated Material With Non-matching Materials* – Many severely deteriorated terra cotta units were replaced with precast concrete in the early 1990s and earlier (Figure 4). This occurred at the bell tower mullions and at the stained glass window mullions. In each case, the precast concrete units matched the profile of the original terra cotta but not the terra cotta's color and texture. The replacement with a non-matching material did not by itself cause further deterioration. The overall appearance of the substitute material however, diminished the aesthetic integrity of the building features. Due to the lack of understanding of deterioration mechanisms, the precast concrete units failed (just as the terra cotta units before them had failed) because the underlying steel was not appropriately repaired (see below for further discussion). We repaired the corroding steel and replaced the precast concrete with new terra cotta that matched the profile, color and texture of the original terra cotta.

Figure 4 – Precast concrete used as a replacement material at the bell tower mullions

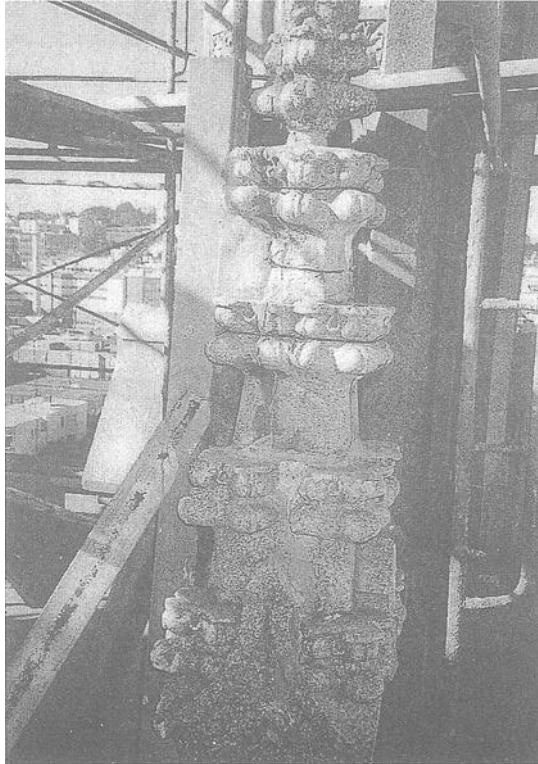
slab. The final outcome was a mixed success. Although some terra cotta was reused, the finials were not assembled with the original units. Parts from other finials (possibly from the lantern) were added, which changed the original design. While the steel angles provided adequate bracing, they were visible from the street. Some of the other means used to repair the finials resulted instead in further damage. For example, stainless steel pins used to connect the terra cotta to the bracing went through the face of the terra cotta, and thereby provided entry points for water infiltration that caused corrosion of the internal steel support. An expansive foam adhesive applied to the cracked surfaces eventually degraded, allowing the cycle of steel corrosion and cracking of the terra cotta to reoccur.

Figure 5 –*Intermediate finial repaired in the early 1990s*

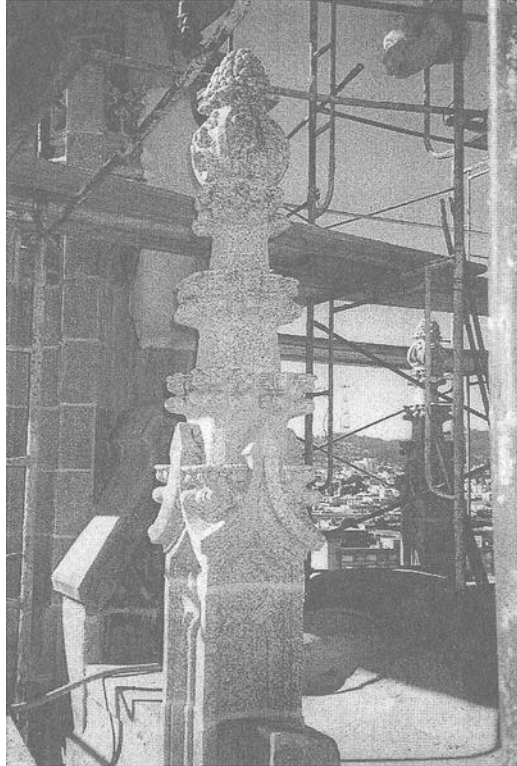
Figure 6 –Intermediate finial as restored in 2002

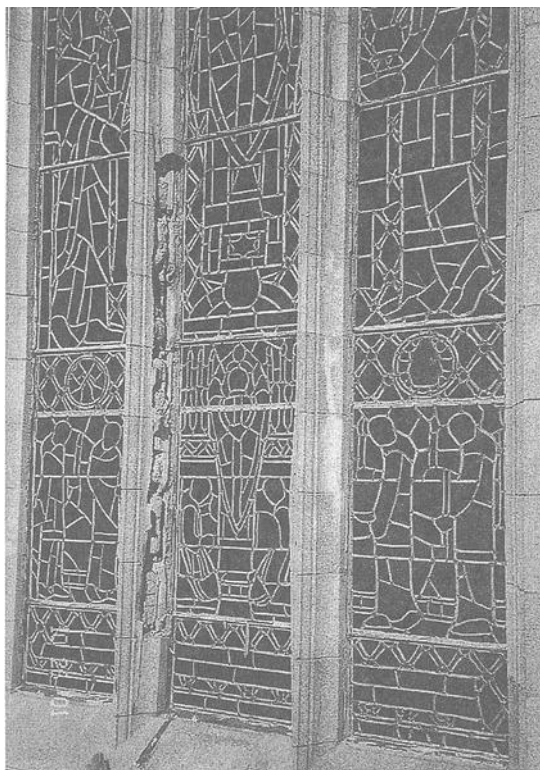
The failure to address the cause of the problem was particularly damaging at the stained glass window mullions, where several cracked mullions collapsed and jeopardized the historic windows (Figure 7). Fortunately, the fallen terra cotta landed on a roof and the stained glass panels remained in place. However, many other stained glass windows were located along walls closer to the streets and sidewalks. It was not only imperative to protect the public, repair deteriorated mullions and prevent future deterioration, but also to prevent loss of the valuable stained glass windows.

Figure 7 – *Collapsed Stained Glass Window Mullions*

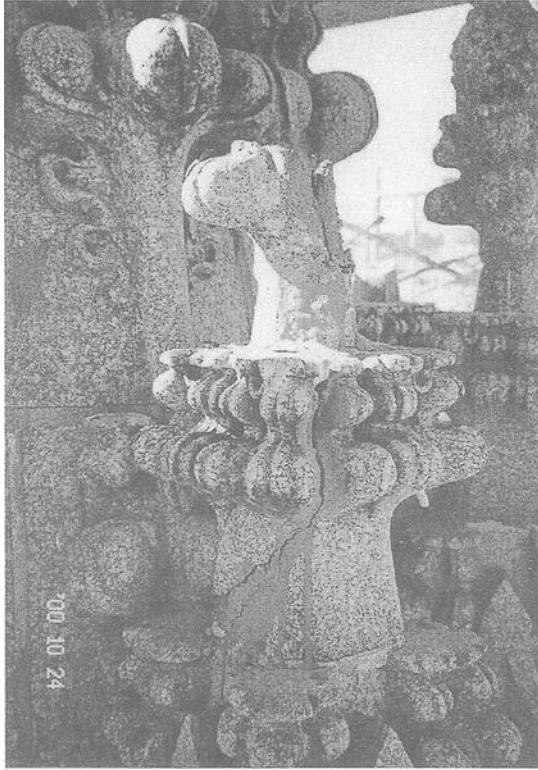
Figure 8 – Small finial with the original corroded steel left in place during the early 1990s repairs

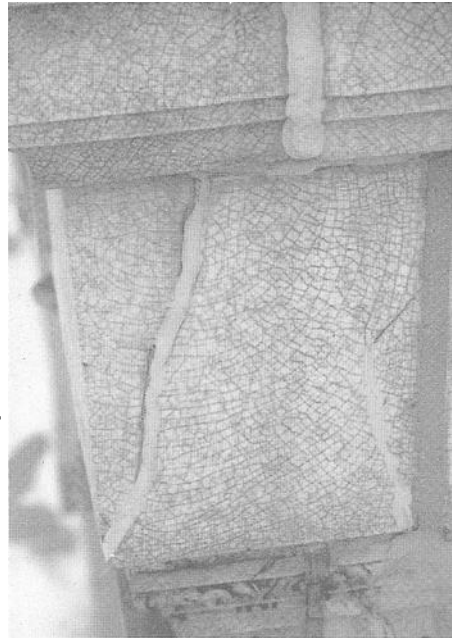
hence its smallest state, immediately after firing. Over time, the body of the terra cotta unit will expand as it absorbs moisture from the air and other sources. This puts the glaze layer into tension, and being a hard, brittle material, it frequently cannot accommodate the expansion of the main body. Under these conditions, the glaze will crack. Cracking in and of itself is not a serious failure, but it can lead to increased water absorption by the terra cotta unit, especially if the cracks penetrate the full depth of the glazing. Increased water absorption by the terra cotta can lead to some of the more severe problems discussed below.

Figure 4 - Glaze Cracking

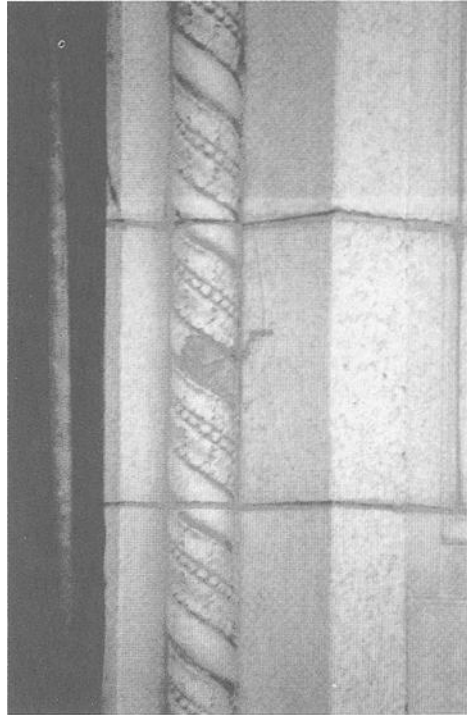
- Within all masonry systems, migrating water can pick up and carry water-soluble salts with it. If these salts are deposited on the surface of the masonry, the phenomenon is known as “efflorescence.” If the terra cotta glaze is compromised by crazing, or if it is slightly more permeable, moisture may evaporate, but the water-soluble salts are deposited within the boundary layer underneath the glaze. This phenomenon is known as “subflorescence,” and the buildup of salt deposits can exert pressure that eventually dislodges sections of the glaze.

Figure 5 - Glaze Spall

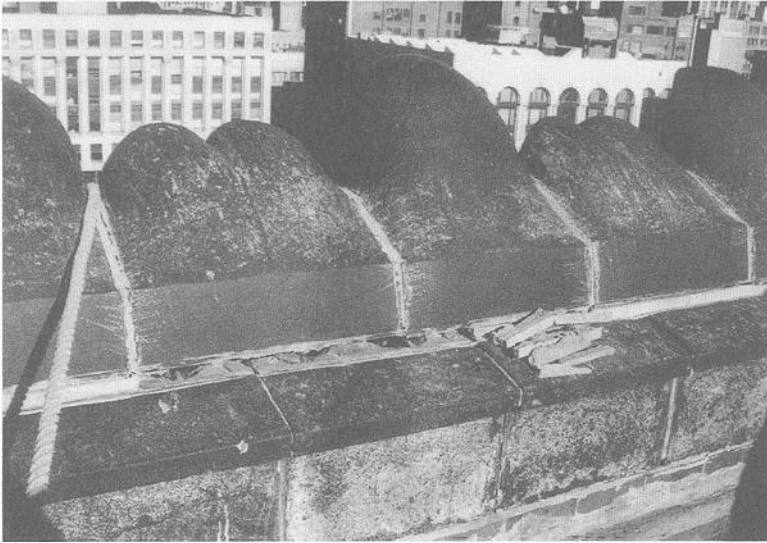
systems, and rely more heavily on the mortar joints for this purpose due to the relative impermeability of the glazed terra cotta units. Deteriorated mortar joints are a primary source of water infiltration into the system, which in turn leads to many of the other problems discussed in this section. The deterioration can be caused by a variety of different mechanisms, ranging from deficiencies in the original mortar installation or mortar mix, to erosion from weathering and attack by air and waterborne chemicals or biological elements. Mortar deterioration is common and is to be expected over time.

Figure 6 - *Mortar Deterioration*

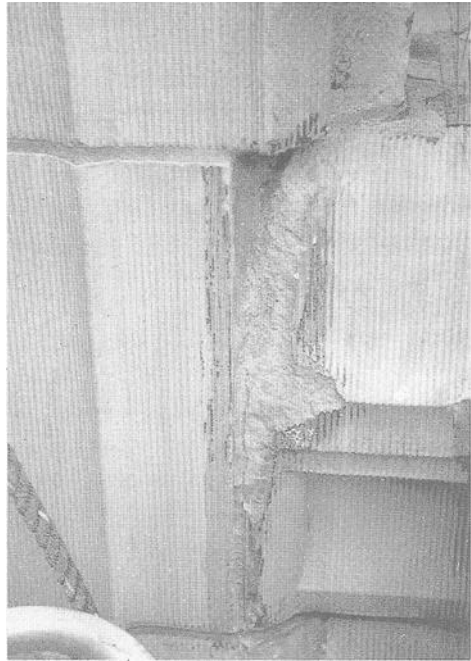
The very formation of corrosion by-product is a problem in and of itself. Iron or steel components, in contact with water, corrode and form iron oxides. Iron oxides occupy five to ten times the volume of the original iron or steel. This expansive formation of the oxides puts a tremendous amount of pressure on the adjacent terra cotta. This is especially prevalent on shelf angles and lintels, where water can pool and cause corrosion of the steel. The horizontal legs of the angles are usually embedded within mortar joints between terra cotta units, or within C-shaped cavities within the units. The creation of corrosion scale on the horizontal legs of the angles can apply pressure in both the vertical and outward directions. Outward pressure can cause a crack or spall to form within the unit or mortar joint along the toe of the angle, or displace the unit laterally.

Figure 7 - *Material Spall*

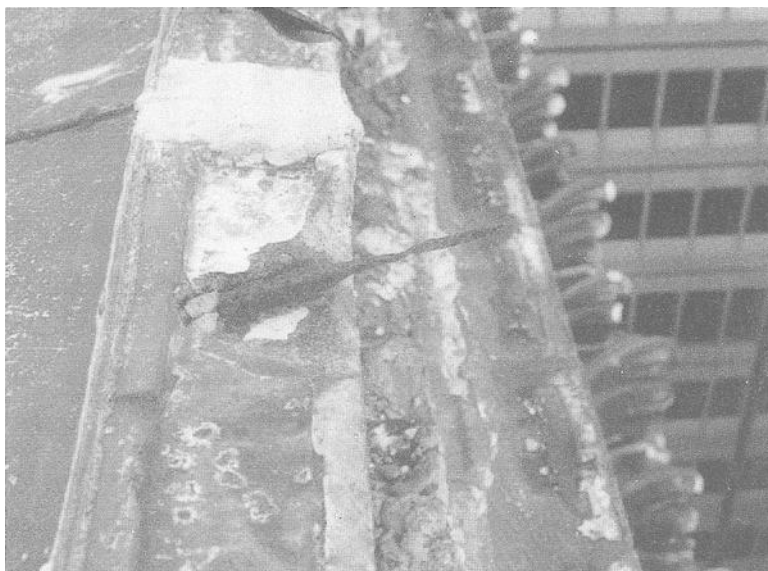
Figure 8 - Corrosion Failure

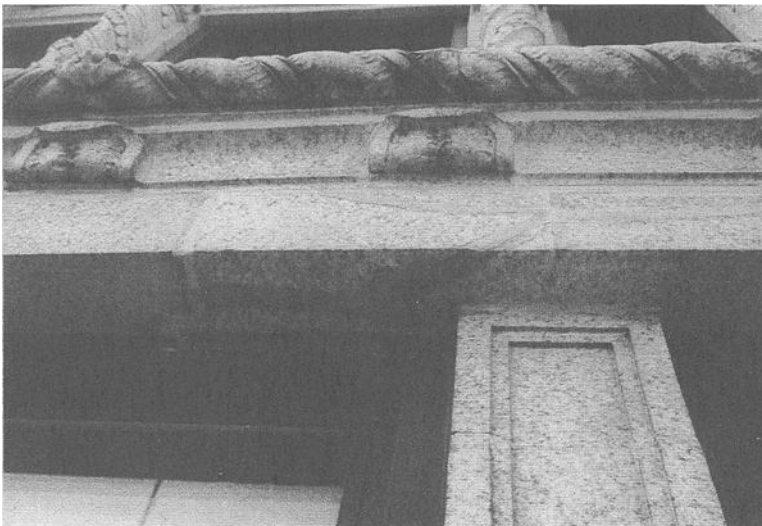
Some building owners with terra cotta facades have been able to support excellent, long-term maintenance and repair programs through the years. Unfortunately, repairs to terra cotta facades have frequently included a multitude of inappropriate measures. “Inappropriate” repairs are not limited to aesthetically unpleasant measures. They are

Figure 9 - *Inappropriate Repairs*

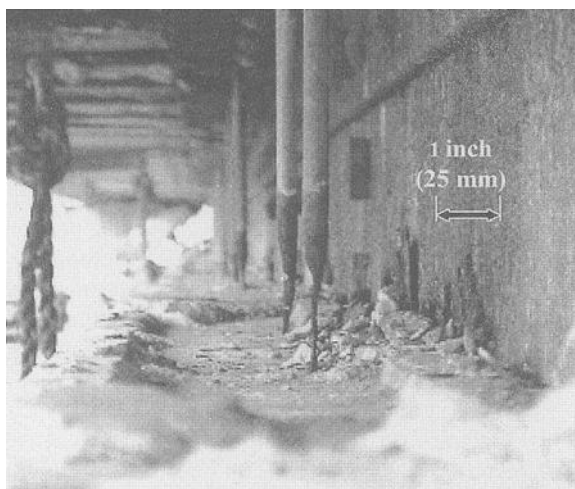
Metal corrosion not only creates a loss of load capacity within a masonry system, it may also induce significant forces within facades due to pack-rust jacking. Corrosion by-products expand and occupy a much larger volume than the original metal. The expansive forces are transferred to surrounding masonry and may induce cracking (see the horizontal cracking at window heads in Figure 2). The installation of elastomeric sealant over masonry cracks in the illustrated building did not alleviate the cause of the corrosion (a leaking roof), so the deterioration continued and the sealant failed. Eventually, portions of the facade were shored and partially dismantled to minimize falling hazards.

Figure 1 – Steel Anchor Corrosion within a Terra Cotta Facade

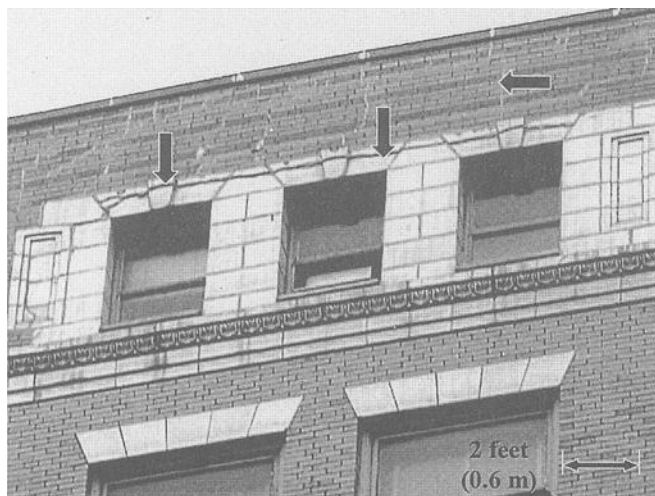
Figure 2 – Masonry Cracking Associated with Pack Rust

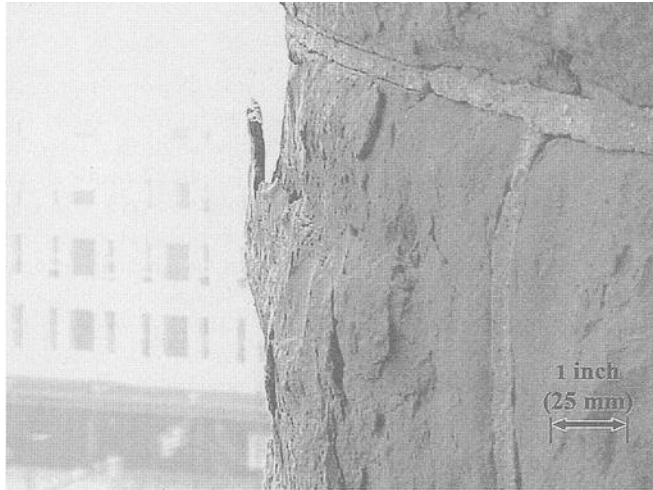
Masonry spalling and exfoliation may result from structural distress such as pack-rust jacking or reactions to adjacent mortar that is too stiff to allow for normal movement. Spalling and exfoliation may also result from water retention within the body of the masonry that can lead to salt re-crystallization or freeze/thaw damage [8]. Regardless of the varied causes, masonry spalls and exfoliation result in unstable conditions where loosened masonry may fall into the street (see Figure 3).

Figure 3 – *Stone Exfoliation on the Tenth Floor of an Historic Building Overlooking a Sidewalk and Street*

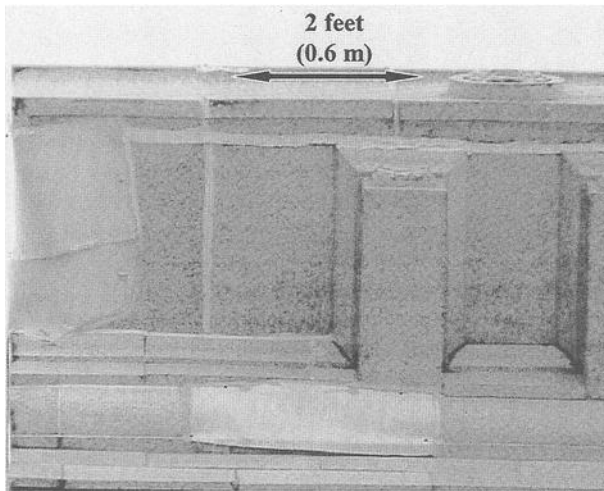
Figure 4 – *Temporary Flashing for the Underside of a Terra Cotta Cornice  
(Viewed looking up from the street)*

*Protection* – Performing emergency facade repairs may adversely affect the performance of the building envelope. For example, removing dentils from a terra cotta cornice could leave open paths for water infiltration into adjacent facade elements or occupied spaces. Prolonged exposure to water infiltration often caused the facade instability in the first place and could introduce several other problems to the building. Therefore, any emergency repair that may increase water infiltration should also include the design of supplemental water barriers such as temporary flashing or sealant (see Figure 4 for an example of flashing installed by a contractor without the involvement of a consultant). In the interest of future restoration, care must be taken to use sealants that may be removed and that will not stain or leave a residue on the surrounding masonry. Flashings or covers should not trap water and in some instances should be selected so as to not trap water vapor and create condensation. Flashings or protective covers should be fastened into mortar joints instead of masonry units wherever possible. The temporary flashing shown in Figure 4 only meets some of the requirements mentioned above.

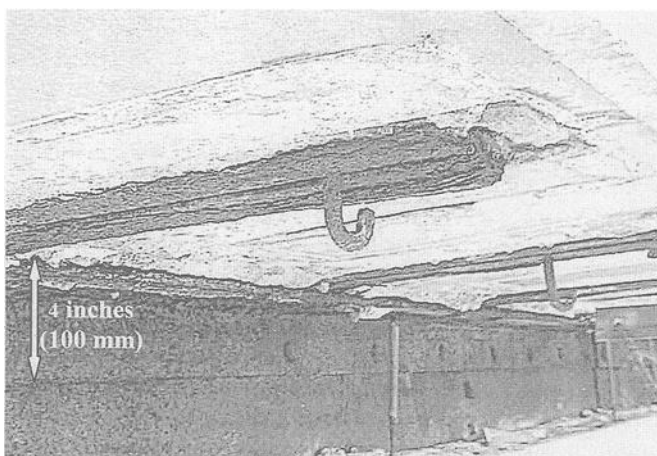
Figure 5 – Severe Steel Corrosion within a Terra Cotta Cornice

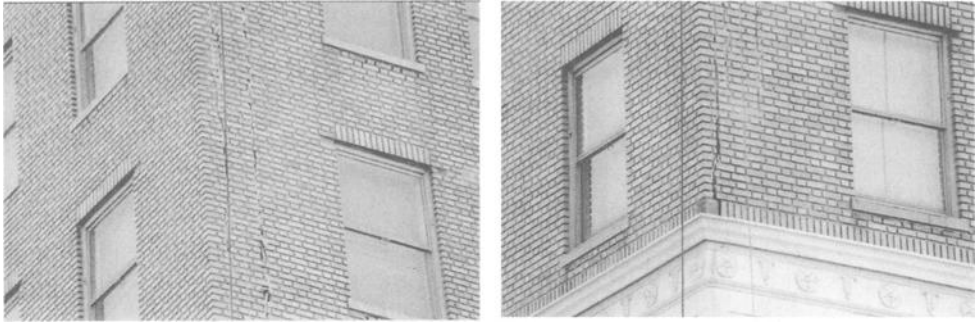
By 1991, five of the six building corners had cracked generally over the full height of the brick masonry with some cracking extending into the limestone facade below the brick (see Figure 2). The building owner did not recognize the distress as a potential structural concern but rather as an aesthetic nuisance. He had for a number of years paid contractors to fill the cracks with sealant “to keep the water out of the building” and to make the cracks disappear (see Figure 3).

Figure 2 - *Corner Cracking in Brick and Limestone Facade*

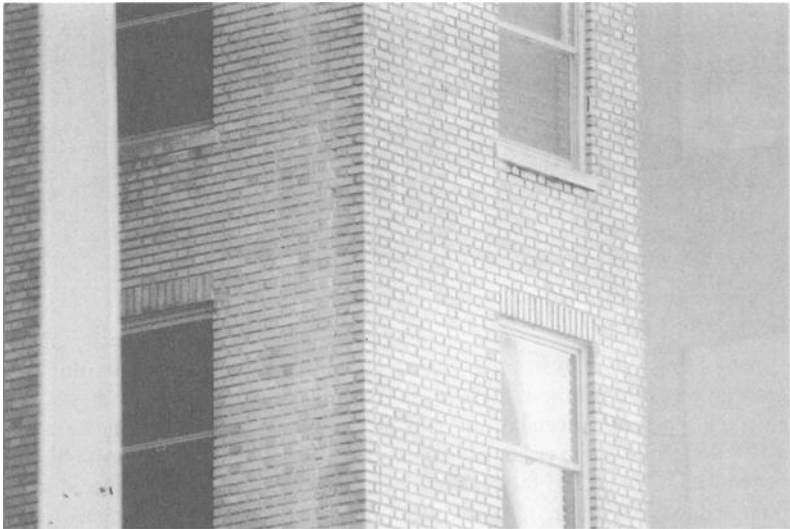
Figure 3 - *Sealed Brick Cracks at the Building Corners*

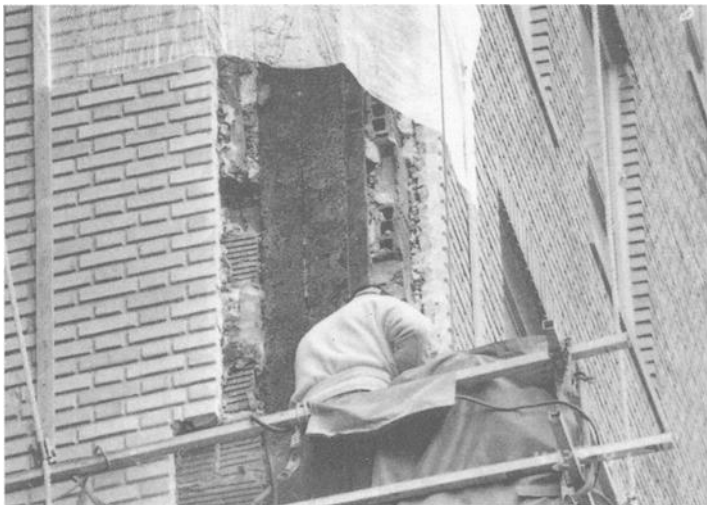
Figure 4 - Typical Corrosion of the Steel Columns at the Building Corners

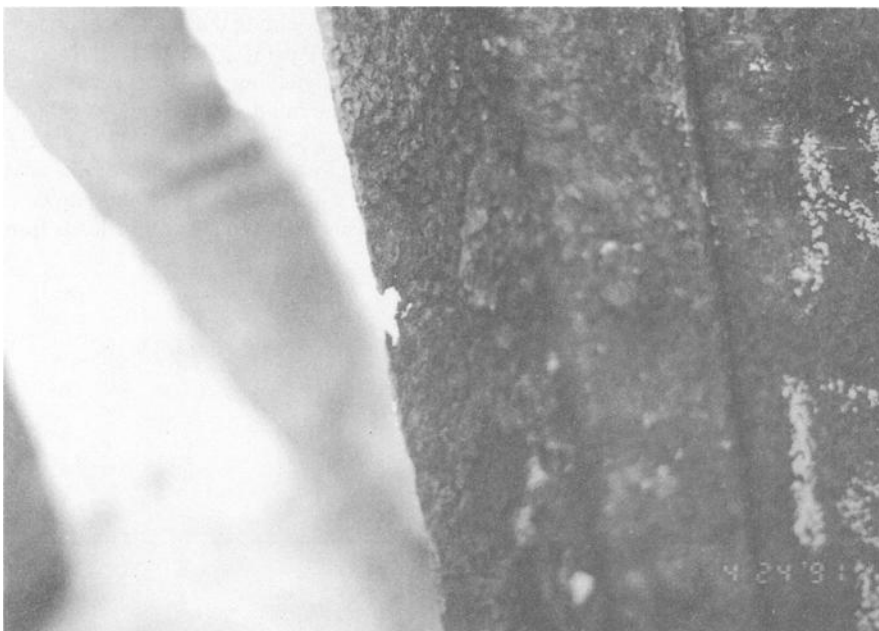
on the north facade about a busy public sidewalk. The corrosion had severely weakened the steel perimeter elements and the adequacy of these elements had to be addressed.

Figure 5 - Severe Corrosion of the Steel Column Flanges

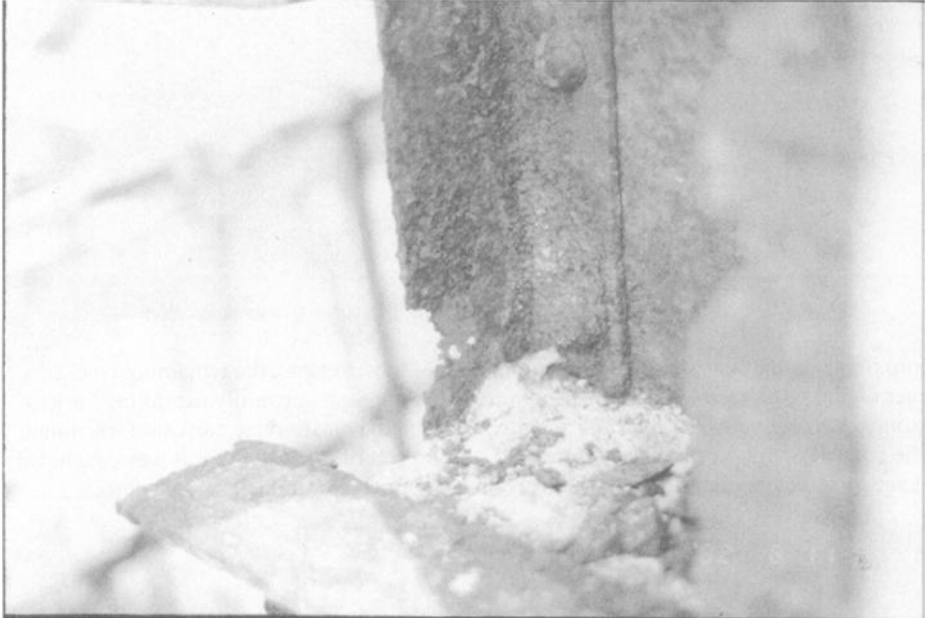
Figure 11 - Severe Column Flange Corrosion on Southwest Corner

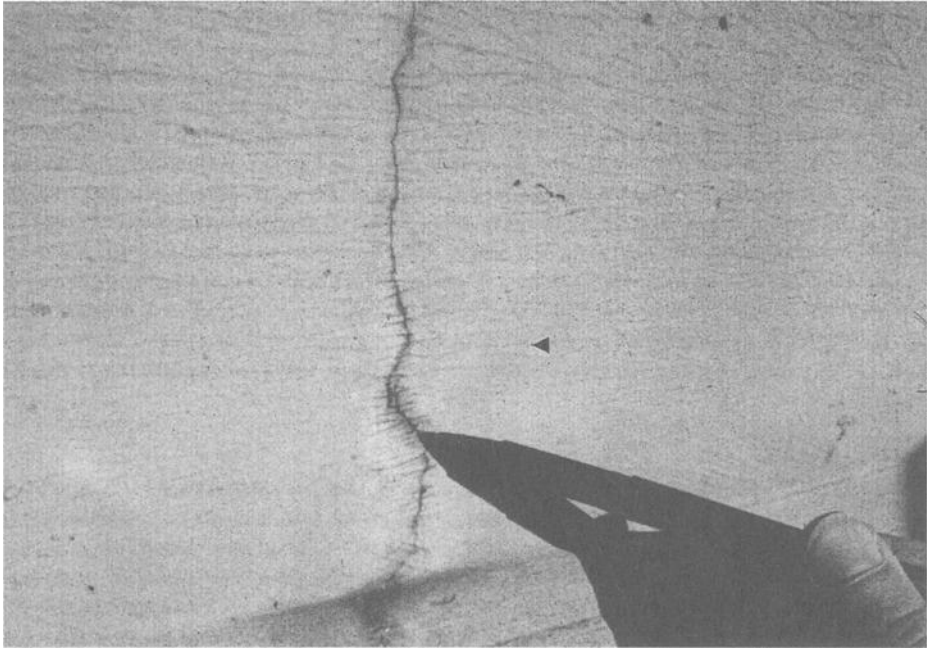
FIG. 1 -View of cracking distress in slab edge.

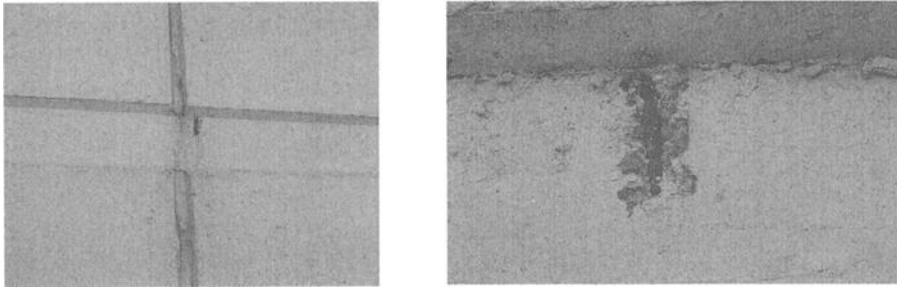
FIG. 4 - *View of distress caused by exposed reinforcing at slab edge at shear wall.*

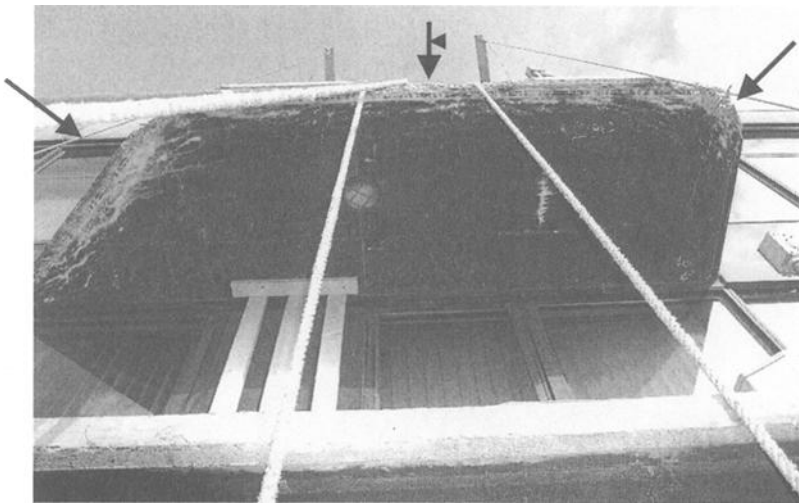
FIG. 5 - *Severe freeze-thaw damage on a concrete balcony slab in a building. The arrow indicates surface degradation at edge of balcony. During the repair project this entire balcony slab had to be reconstructed.*

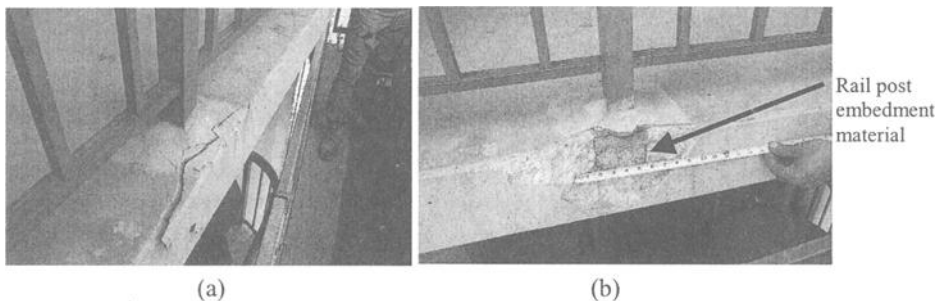
FIG. 6 - Concrete cracking and delamination observed at a balcony edge (a). When the spall was removed, as shown in figure (b), no reinforcing steel was observed behind the spall. In this case the cause of the distress was the use of an inappropriate balcony rail post embedment material.

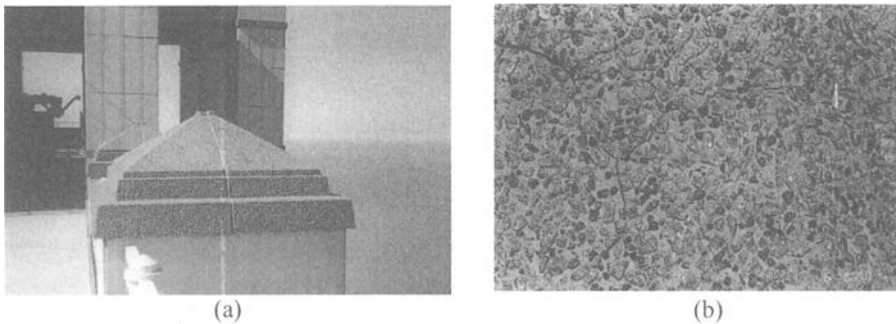
FIG. 8 - *Figure (a) shows a column capital cover with extensive cracking distress. Figure (b) shows a close-up of observed cracking which was determined by laboratory analysis to be caused by alkali-silica reaction.*

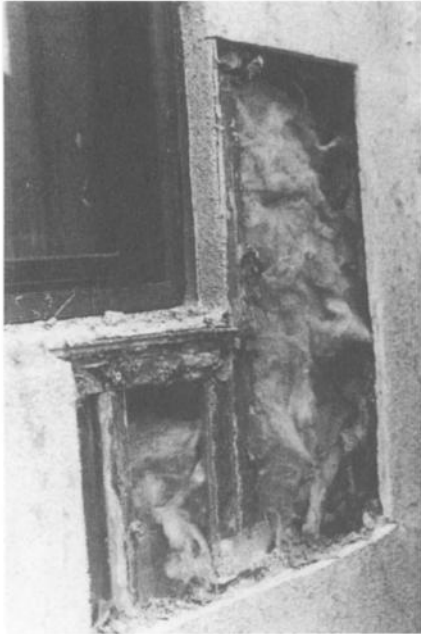
*Figure 5 - Water leakage through this skin barrier stucco system has caused corrosion and other damage to interior wall components.*

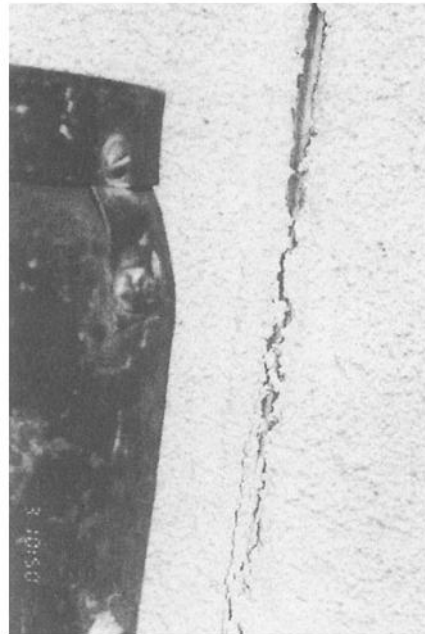
*Figure 6 - Coating and sealant failure allows water to enter skin barrier systems.*
