# **BUILDING** *FACADE* *MAINTENANCE, REPAIR,* *and INSPECTION*

STP 1444

# ***Building Façade Maintenance, Repair, and Inspection***

## Reporting Unsafe Conditions at Public Schools and Private Structures

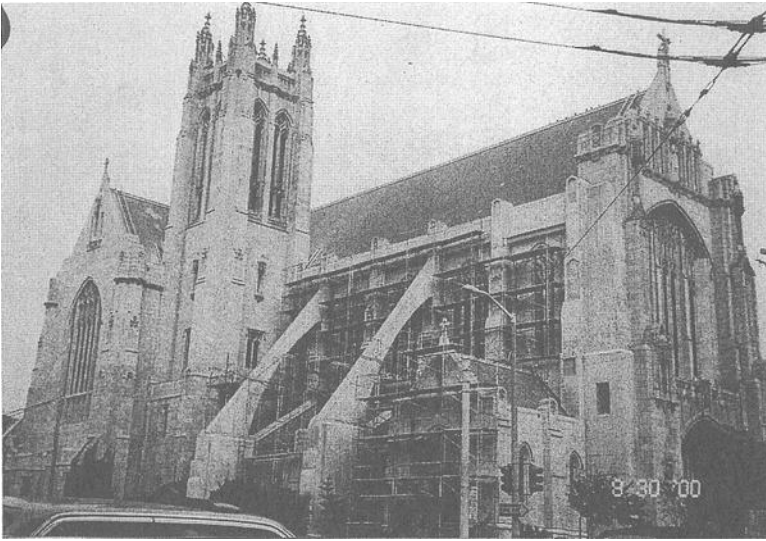
Figure 3 – Saint Dominic's Church with the flying buttresses and bell tower with no lantern

*Removal of a Significant Building Feature* - One of the first areas of the building needing immediate attention after the earthquake was the severely damaged 25-foot tall, ornate terra cotta lantern, located atop the 125-foot, terra cotta bell tower (Figure 1). The engineer-in-charge at the time determined that the lantern's unsafe condition warranted its complete removal. The removal of the lantern resulted in the loss of the bell tower's visual prominence and the apparent loss of original material (Figure 3).

*Changes to the Defining Characteristics of the Building* - The early 1990s seismic retrofit consisted of installing a series of flying buttresses to the exterior walls. The buttresses were anchored to a new concrete ring beam at the base of the roof and to several caissons extending deeply into the ground. The result significantly altered what was originally a gothic revival design into a high-gothic design (Figure 3). In addition, the buttresses and the roof ring beam were made of concrete; a marked contrast to the granite patternglazed terra cotta cladding. We did not attempt to correct for this change. While the flying buttresses do not meet the established standards for the care of historic structures because they drastically alter the original design, they provide a creative solution utilizing medieval construction concepts to solve modern day seismic requirements. The result is both dramatic and conscious of its architectural forbears. The flying buttresses also allowed the Church to preserve the building's interior space and appearance.

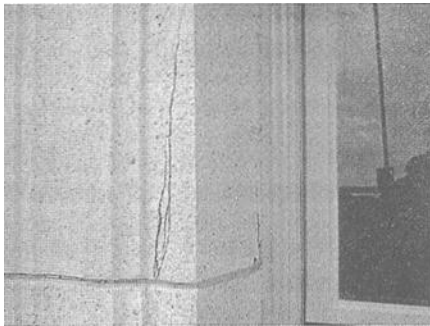
Figure 1 – Crack in granite window jamb about 400 mm (16 in.) long. Visible from grade.

The area of the facade where cracks shown in Figure 1 and Figure 2 were located was not part of the 10% that was surveyed in detail, so these repairs were not specifically called out on the bid documents. Thus, the actual total repair quantities required could not be determined until construction. Only repair quantity estimates could be calculated, based on the detailed survey. The repair quantities were extrapolated over the entire facade, using the preliminary survey as a guide. This new quantity estimate would form the basis of the quantities listed in the bid documents. In the bidding documents, the base bid quantity included 800 helical pins and 205 dutchman repairs, compared to 54 helical pins and 103 dutchman repairs which were specifically indicated on the drawings.

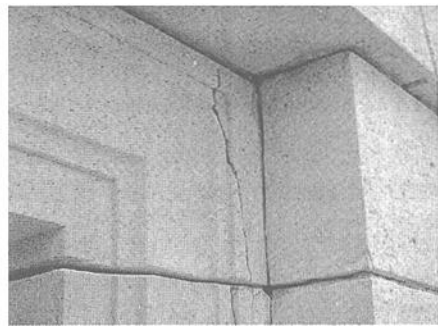
Figure 2 – Crack in granite window header about 500 mm (20 in.) long. Not visible from grade.

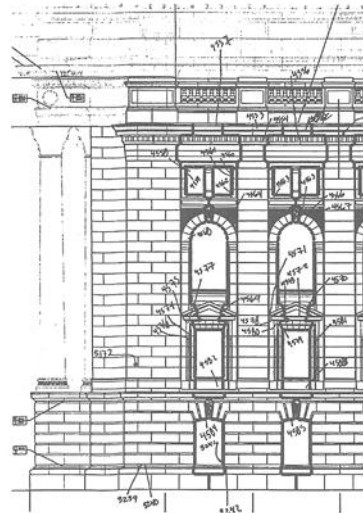
Figure 4 – *Typical partial elevation with distress locations noted*

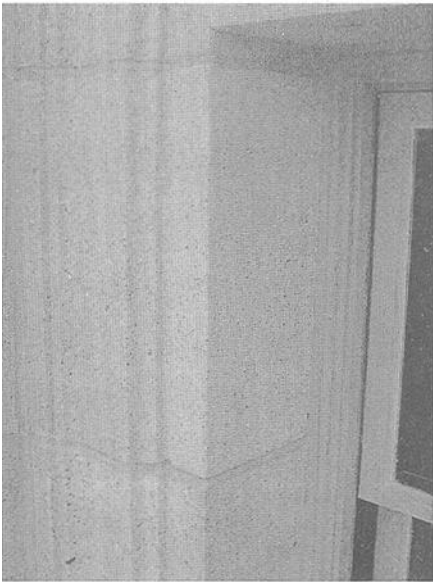
A copy of the repair design sheet (Figure 5) was provided to the contractor, along with the overview elevation indicating where each photograph was located (Figure 4). The contractor then proceeded to implement the stone repairs. The dutchman repairs occasionally required further discussion with the A/E; for example, when cracks penetrated into the stone in a different angle than originally anticipated. At times the stone proved to be less stable than expected when attempting a helical pin repair, and broke during the drilling of the pin. The contractor notified the A/E, and a dutchman repair was usually substituted. For example, the cracked portion of the stone at repair 4560 had been held in place only by the intact mortar joint; once the mortar was removed for repointing, it was noted that the stone was actually significantly deteriorated. The A/E quickly determined that a dutchman repair was therefore appropriate.

Figure 6 – *Repair photograph 5150*

Because of the goal to preserve as much historic fabric as possible, many repairs were designed with instructions that the contractor attempt a pin-in-place repair first. A dutchman repair was an acceptable alternative, in cases where the cracking was too extensive for pinning to be implemented successfully.

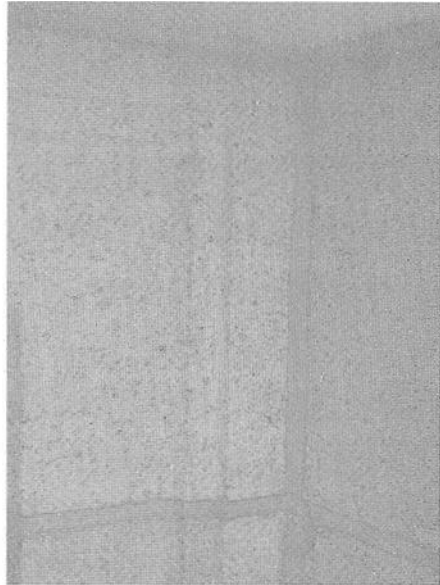
Figure 7 – *Repair photograph 5151*

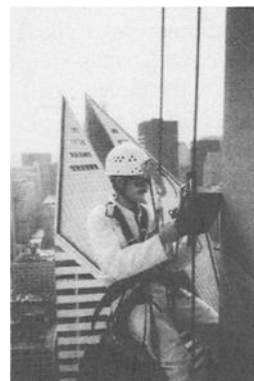
Rope Access facilitated a successful hands-on inspection (Figure 4) of defects on the exterior facade of a 185-m tall building. Existing house rigs were not operational, and the mast-climbing scaffolding, installed for the facade repairs, could not be operated due to a city-wide ban on the use of these platforms. Rope Access was also used to perform weld inspections on the radio antenna above the same building, 265-m above the ground, and perform the interior inspection of the 185-m chimney liner in the building. The antenna and chimney inspections were performed over a weekend to minimize down time to the radio antenna and the building's heating system.

Figure 4 - Case Study 3

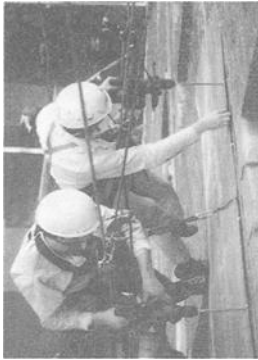
Figure 5 – Case Study 4

Initially, hands-on inspection of the exterior facade of a 12-story tall, ornamental and historic building occupying an entire city block was completed in four days utilizing Rope Access. Deteriorated conditions of the exterior facade and potential vibration damage from the adjoining construction activity made the need for emergency stabilization of the facade a necessity. Excavation at two sides of the building, a deep wood-framed cornice and lack of proper tie-backs prevented the use of scaffolding, boom truck, or lifts for the repairs. Rope Access technicians implemented the engineers' emergency stabilization and temporary repairs (Figure 5) (removing loose debris, stitching, netting, and banding displaced and cracked masonry) economically and efficiently.

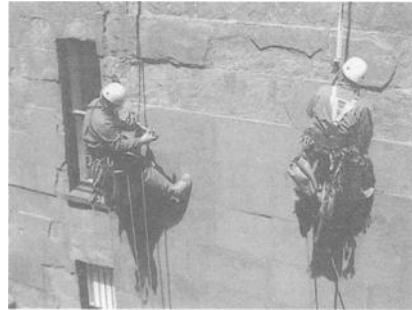
The building, located in an historic section of the city, is five stories and about 25-m tall with a mansard roof. The exterior walls are load-bearing masonry faced on the exterior with brownstone and brick. During a condition survey of the exterior building envelope, engineers identified loose and incipient spalls in the brownstone on the two street elevations and to the rear of the building. Under direction of the engineers, Rope Access technicians performed a hands-on inspection and removed loose and incipient spalls (Figure 6).

Figure 6 – Case Study 5

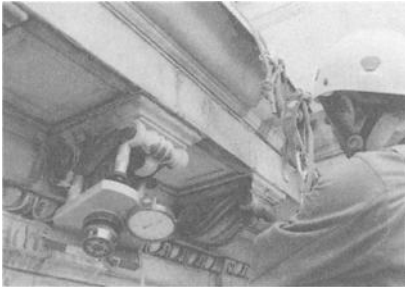
Rope Access technicians assisted the engineers with a condition assessment of the exterior facade of a museum over a period of four days. The condition assessment of the facade identified loose stone modillions below the vertical joint of the cornice. Because of the manicured grounds, safety, security and visual concerns, the client was adamant that technicians minimize the impact of the emergency repair activities on the museum.

Figure 7 – Case Study 6

Rope Access technicians removed loose modillions, and the balance of the modillions were anchored to the backup and load tested (Figure 7).

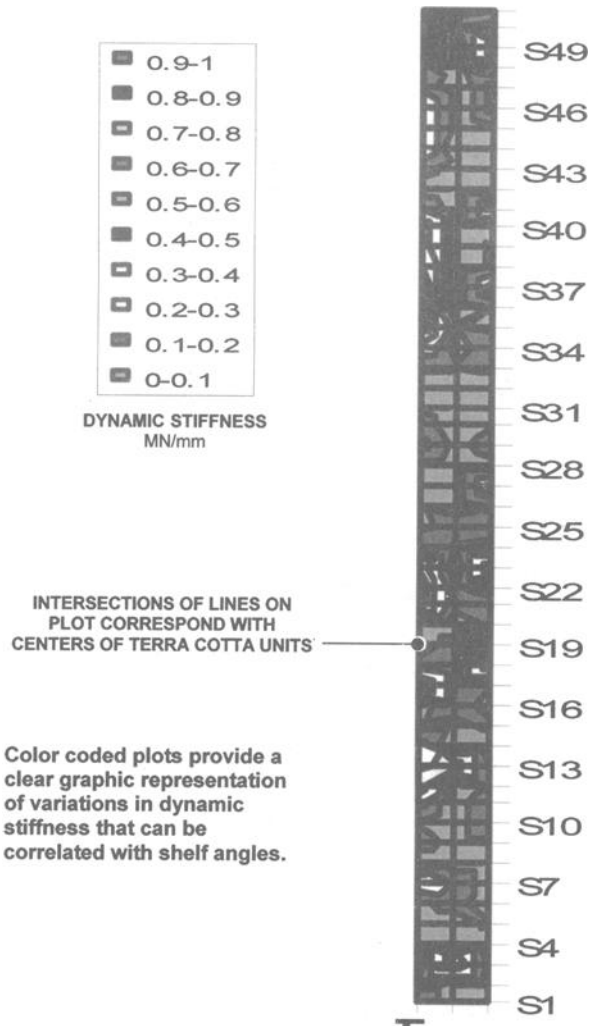
FIG. 7 – Plot of Dynamic Stiffness versus Position of Terra Cotta Units of Column Cover for Wrigley Building

The results from in-situ strain relief test were combined with these results to determine the actual distress that existed in the column cover and the mullion terra cotta elements, was caused by localized corrosion of the steel shelf angles located at each floor line over the height of these nine-story high elements. The vertical stacking of the total terra cotta weight over the height of the building clearly did not cause the distress. The most dramatic finding of this study was that the weight of the terra cotta cladding was being supported more by its attachment to the backup materials than by the steel shelf angles. This was more evident on the terra cotta mullions than on the much larger column covers.

It was further discovered through this testing that the magnitude of the compressive stresses in the terra cotta column cover was much lower than would be expected for vertical stacking, which would be a function of both the location of the unit in the height of the building and the weight of the individual units. However, these test results do indicate that corrosion of tightly embedded steel shelf angle with no relief joint beneath can result in relatively high, localized compression stresses within the terra cotta;

certainly high enough to cause vertical splitting of the terra cotta units above and below those elements.

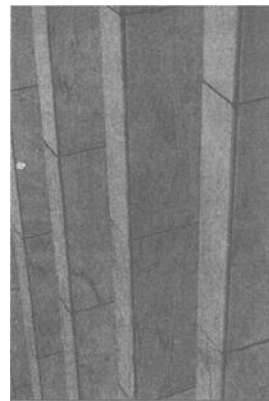
Cracked slender cladding panels.

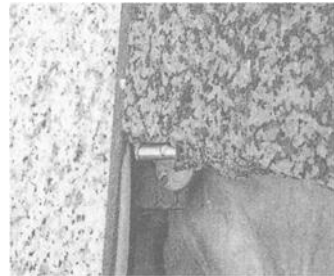
Stone panel failure at anchor.

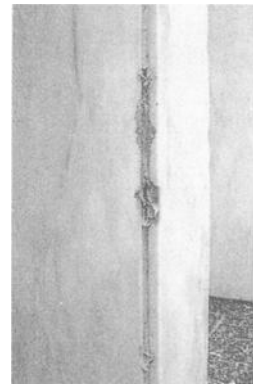
Failed sealants at cladding joint.

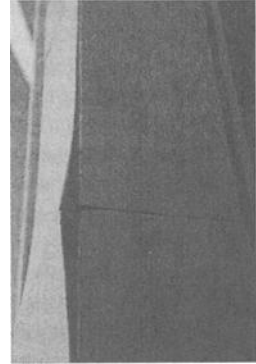
Failure of cladding due to unaccommodated movement

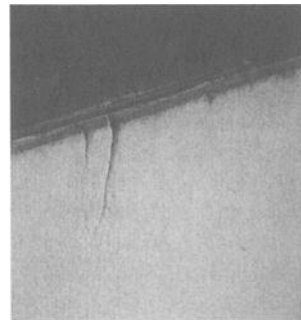
Erosion due to weathering.

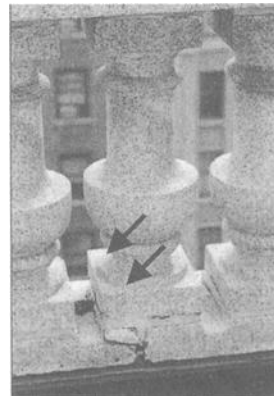
Corrosion damage.

units together, align them vertically, and level them. The anchors were usually set tightly into holes in the stone with setting mortar or shims. Leveling shims are typically compressed between stone units. Over time, the metal breaks down in the presence of moisture and oxygen, forming iron oxide, or rust scale. The scale takes up significantly more volume than the original base metal, thereby applying pressure on the surfaces it contacts. If the stresses are greater than the capacity of the stone unit to restrain it, a crack or spall develops. The formed crack or spall, if left untreated, allows more moisture and air to reach the steel elements, feeding a cycle of further corrosion and subsequent damage.

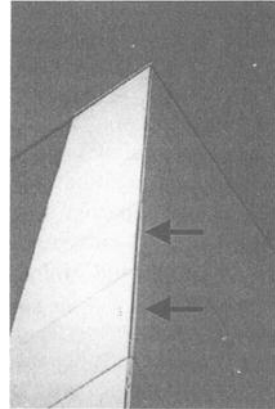
Bowing of marble cladding.

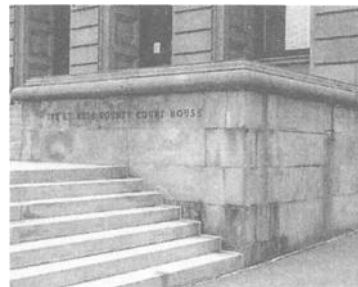
Soiling and staining of stone features.

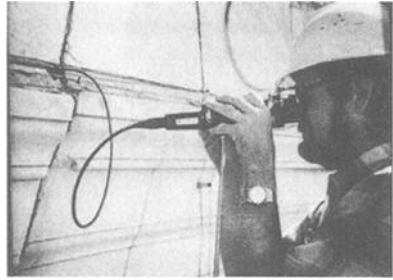
Borescope examination lamination.

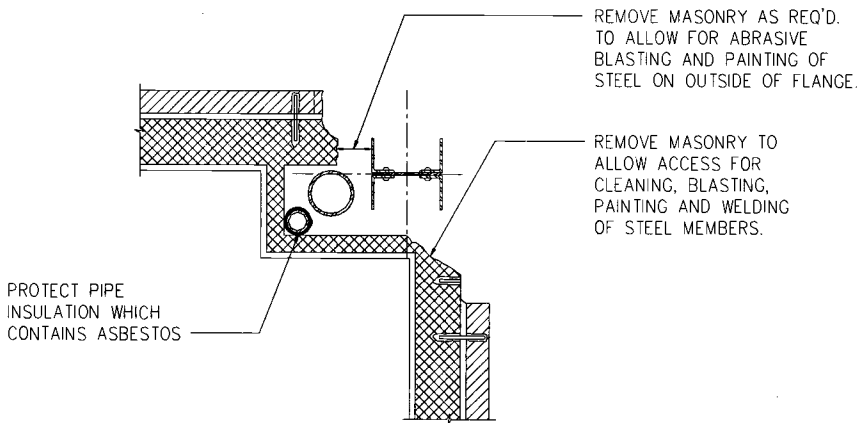
Figure - 6 Existing Column Cross Section \

published in 1927. It was determined that the steel likely had a yield of 27.5 ksi (189.6 MPa) and was probably designed for a maximum compressive stress of 13 to 15 ksi (89.6 to 103.4 MPa). At each critical location, for each of the measured cross sections, the factor of safety,  $FS_b$ , against “Critical Euler Buckling” and against yielding due to “Compression plus Eccentric Bending”,  $FS_{y1}$ , were calculated for the DL + 10 psf (0.479 kN/m) LL load case for the four corner columns. The factor of safety against yielding,  $FS_{y2}$ , under full compressive load (no bending) was also calculated for the full design load, DL + 50 psf (2.39 kN/m) LL + 30 psf (1.44 kN/m) Interior Partition Load.  $FS_b$  ranged from 2.53 to 8.22,  $FS_{y1}$  ranged from 1.25 to 1.76 and  $FS_{y2}$  was 1.08 at its worst location. As a result of this analysis, it was concluded that it was safe to repair the columns without shoring the building or removing occupants. As a precaution the building owner removed all storage loads from the corner bays.

steel column and beam sections could be added from the exterior. This remediation scheme had the advantage of producing minimal interior disruption in the occupied building and allowed avoidance of the lower floors near the bank because little corrosion was present in this location. The additional steel was designed to support 100% of the critical design load.

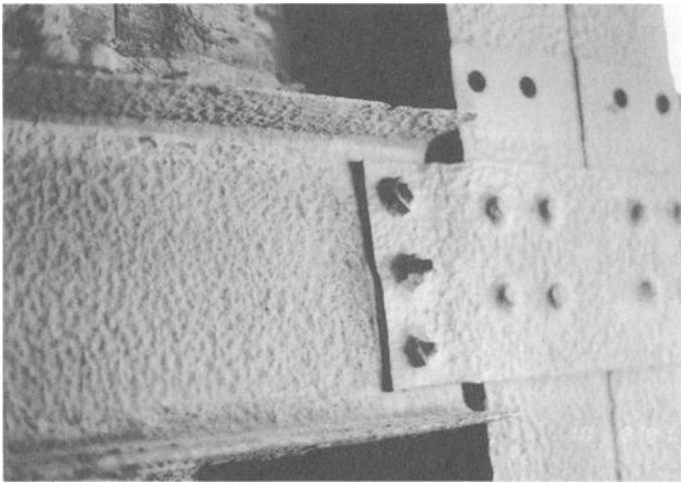
Figure 7 - Prepared Existing Steel Column and Beam

The scope of repairs required to strengthen the steel columns consisted of removing all masonry around the column to permit access, sandblast all exposed surfaces of the existing steel to a near white finish (see Figure 7), taping all areas where welding would occur, painting all existing steel with an organic zinc rich paint and welding steel shapes in place over the full height of each of the four corner columns. Levels 4 through 10 were strengthened by adding three 5" x 4" x ¼" (127 x 102 x 19 mm) angles and an angle of two plates built-up to permit access for final welding on the interior side of the column. Levels 10 through 14 were strengthened by adding three 4" x 4" x ½" (102 x 102 x 13 mm) angles and an angle of two built-up plates to permit access for final welding. All steel was grade 50. Angles and plates were located as shown in Figure 8.

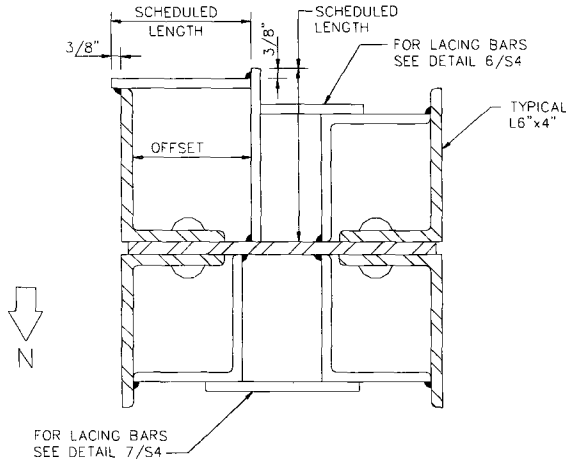
TYPICAL LEVEL 3 TO 10 COLUMNS #1 AND #31

Figure 8 - Section Detail for the Repaired Columns

Four unique problems had to be addressed during the design to ensure all load paths were maintained or redirected to the added steel supports and to ensure that all stresses were within allowable limits. First, at a number of locations the rivets interfered with installation of the new angles and plates. This was addressed in two ways. Since the same size angles were used at several consecutive floors the angles were sized based on the stress conditions at the bottom of the grouping, i.e. levels 4 and 10. At all other floors the added reinforcing was somewhat larger than necessary. Where the angles were larger than necessary the angles were typically notched to pass by the rivets. The reduced section was still sufficient to maintain the stress within an allowable level. Where necessary at the lower levels and at other locations where notching removed too much steel, the added element was reinforced with a plate to strengthen the section.

The second problem area involved the transition splices between added members. Full penetration welding was utilized where splices occurred between ends of angles. Where

angles changed sizes just above the 10<sup>th</sup> floor level, a tapered transition splice was devised to permit loads to be transferred while avoiding stress increasing eccentricities.

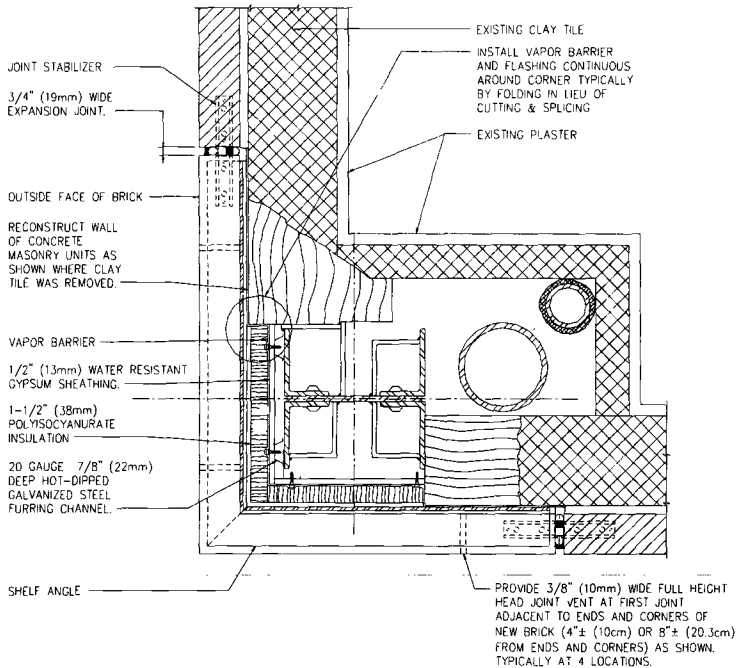
Figure 9 - Typical Strengthened Corner Column Section

The closure of each corner was designed to ensure that cracking and water infiltration would not occur in the repaired corners. The masonry backup wall was not reinstalled around the exterior face of the corner steel columns. Steel shelf angles were installed at each floor level in these areas. Gypsum sheathing was installed on the exterior of the column with

a vapor barrier installed, which extended some distance out onto the exterior face of the clay tile and concrete masonry unit back-up wall and down over metal flashing with drip edge extensions installed upon the shelf angles. Rigid insulation was installed on the exterior of the vapor barrier to prevent condensation on the interior steel surfaces. The brick veneer was installed with horizontal relief joints below the shelf angles and vertical expansion joints to isolate the corner masonry from the adjacent continuous brick facade. Silicone sealant was used in all relief and expansion joints, along with weeps at the shelf angle levels. Figure 9 shows a section of the completed corner repair and Figure 10 shows the repaired column corner after work had been completed.

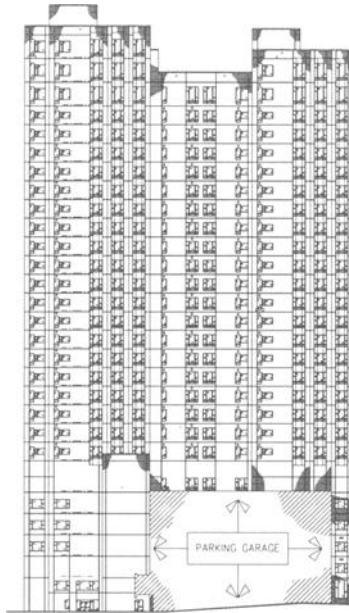
Figure 12 - East Elevation of the Harbor Court Condominium Tower

A 28 story steel framed condominium /office tower in the Inner Harbor area of Baltimore Maryland (Figure 12), came under scrutiny when a section of its brick veneer cracked, dropped off the building and landed on a public sidewalk. This building was designed and built in the mid 1980s and was only about a decade old when the brick veneer failure occurred. Luckily the failure occurred in the early morning hours and no one was around.

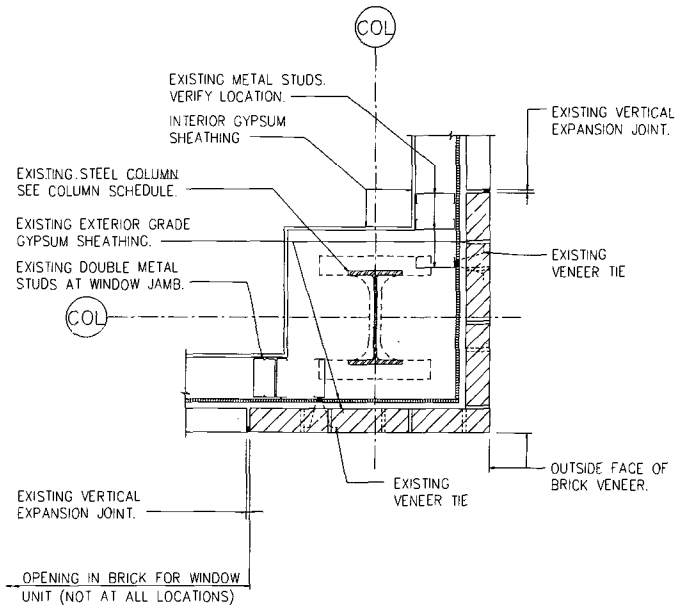
Figure 13 - Plan Section-Typical Corner of the Harbor Court Condominium

Examining the plan sections of a typical corner section (Figure 13) indicates that the brick veneer forms essentially a column cover at this location, with the vertical control joints at approximately 3 ft (.9 m) from each side. In addition, the presence of horizontal expansion joints at the floor levels was intended to separate each level of veneer and thus allow the brick sections at each corner to move independently. There were vertical steel studs placed near the edges of the column flanges, spanning between the floor slabs, that were sheathed on the exterior with exterior grade gypsum wall board. The brick veneer was attached to only the two studs near the column flanges using adjustable veneer ties. There were no veneer ties attached directly to the column. The adjustable ties used in the construction of this building used a "V" wire tie and a backing clip that was fastened to the steel stud using two screws. There was no backing plate between the wire and gypsum sheathing and this resulted in the wire tie bearing directly on the relatively low bearing strength gypsum sheathing.

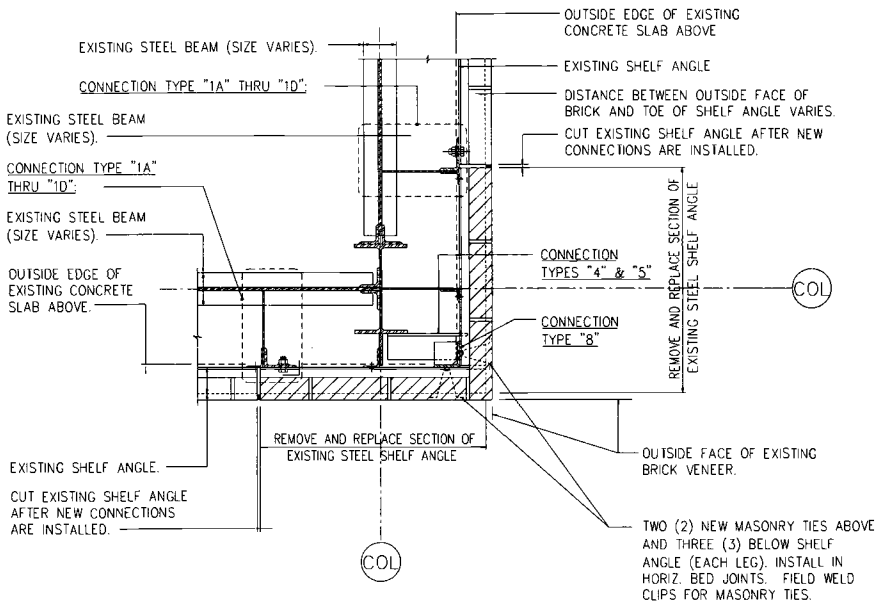
Figure 15 - Plan Section of Corner Area Near Floor Level

Understanding of how the building systems function under loading, knowledge of where potential problems may exist and a systematic site investigation is very important in the evaluation of these facade systems since even careful review of the Harbor Court building plans may not have disclosed the deficiencies in the corner areas. There were notes on the plans that indicated that the studs should be spaced at no more than 16” (406 mm) centers and this implied that they should be located around the column, even though in most cases the 6” Stud (152 mm) would not fit around the column section. As can be seen from examination of the section (Figure 15) the remediation effort added an additional support point on each veneer face, attached directly to the column section. This out-of-plane support was located near the mid height of the sections and near the floor levels (Figure 15).

Careful examination of the section above (Figure 15) also shows vertical support of the brick veneer involves the use of steel shelf angles attached to spandrel beams and the steel column section with shear plates. Site inspection showed that in the corner sections, the steel angles consistently extended across the vertical expansion joints to a shear plate support on the beam. Further, these examinations showed that, in most cases, the steel angle cantilevered from the shear plate attached to the column and did not extend to the corner of the brick.

flexibility may have caused some of the observed brick cracking and spalling. The remediation strategy required the steel shelf angle at the expansion joint to be cut and to provide an additional bolted shear plate connection for the corner angle beside the vertical expansion joint.

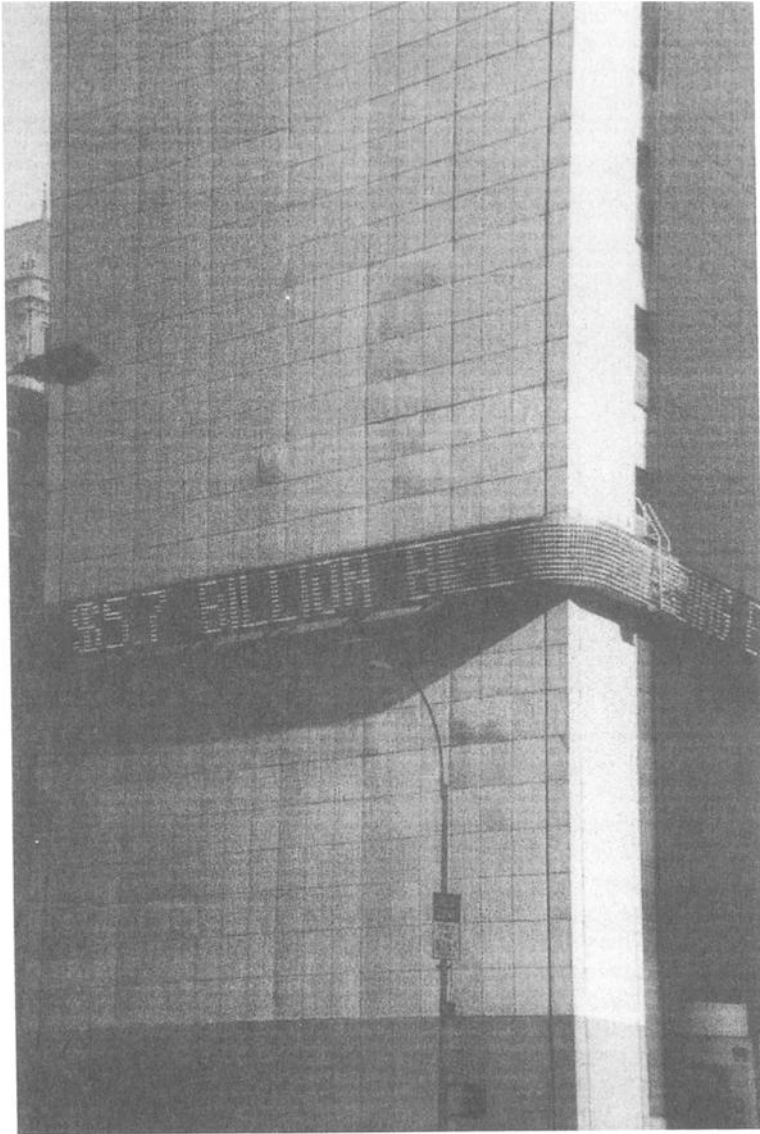
FIG. 1

A number of marble panels exhibited bulging out from the vertical plane by as much as approximately 1/2 in. (1.2 cm) to 1 in. (2.5 cm). Additionally, there were many irregularities in the marble panel facades, such as misalignment of the panels in the vertical and horizontal directions.

Since several marble panels were severely bulged out and loose, it was necessary to install sidewalk bridges along the affected facades for protection purposes.

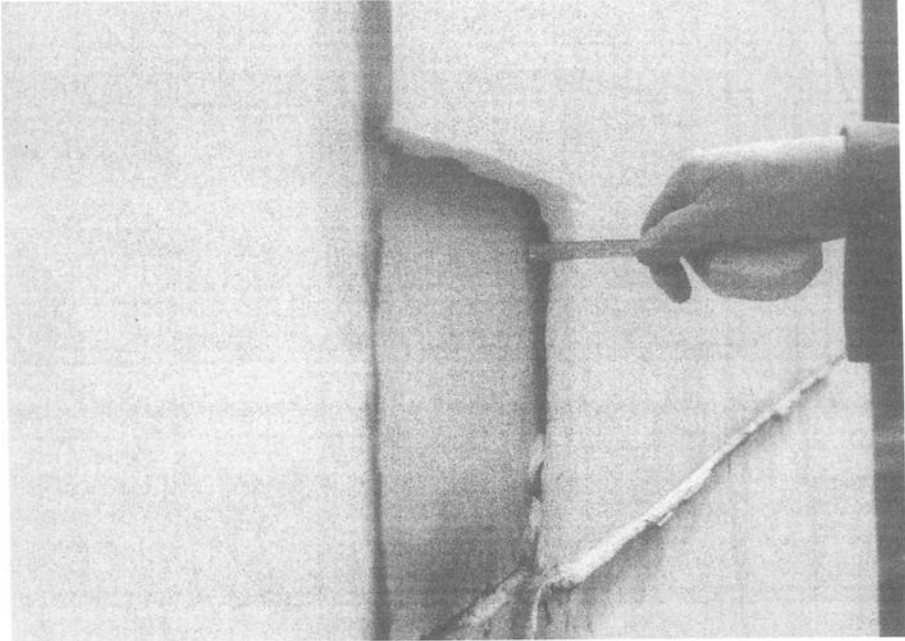
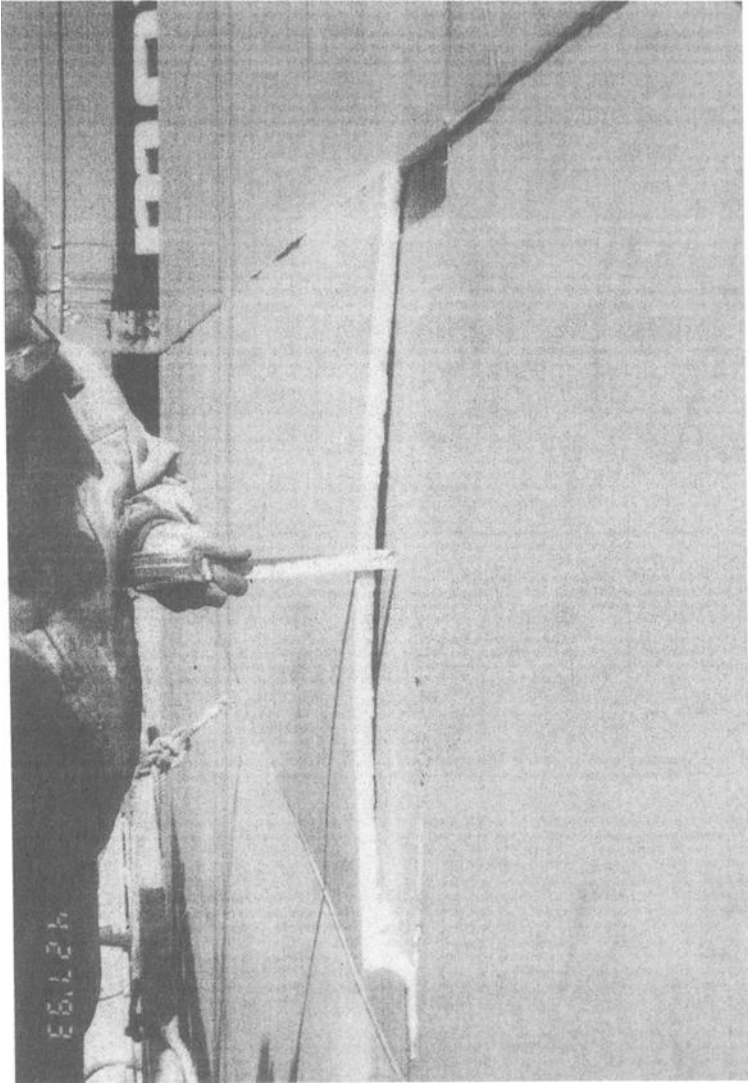
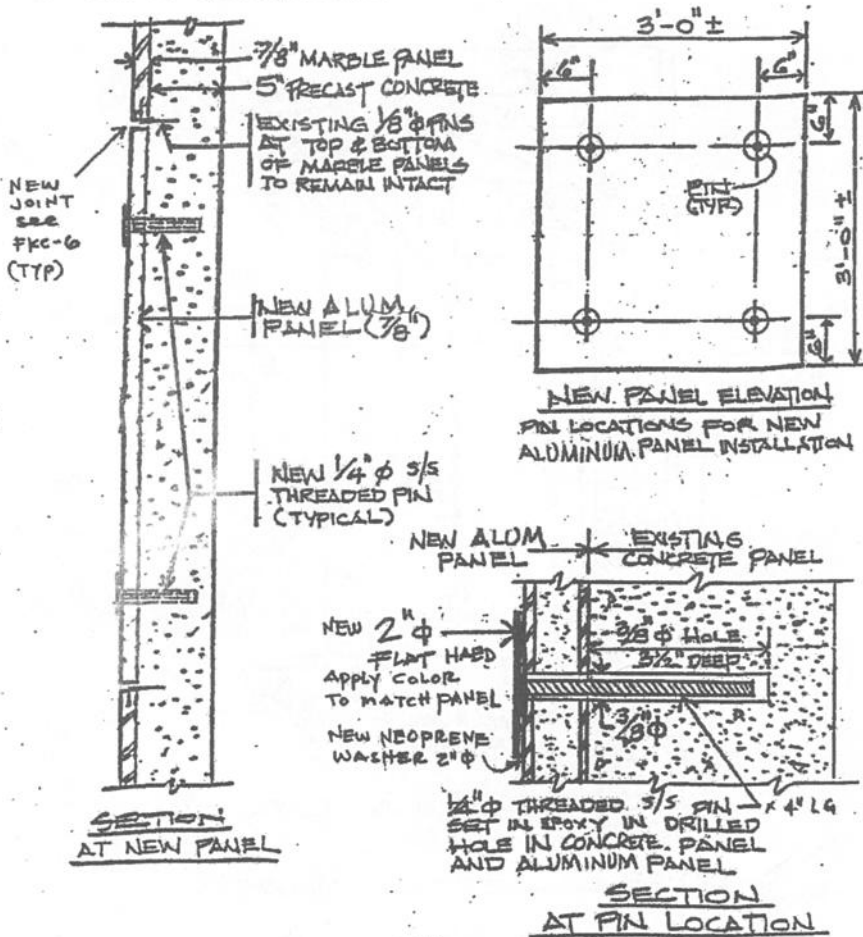
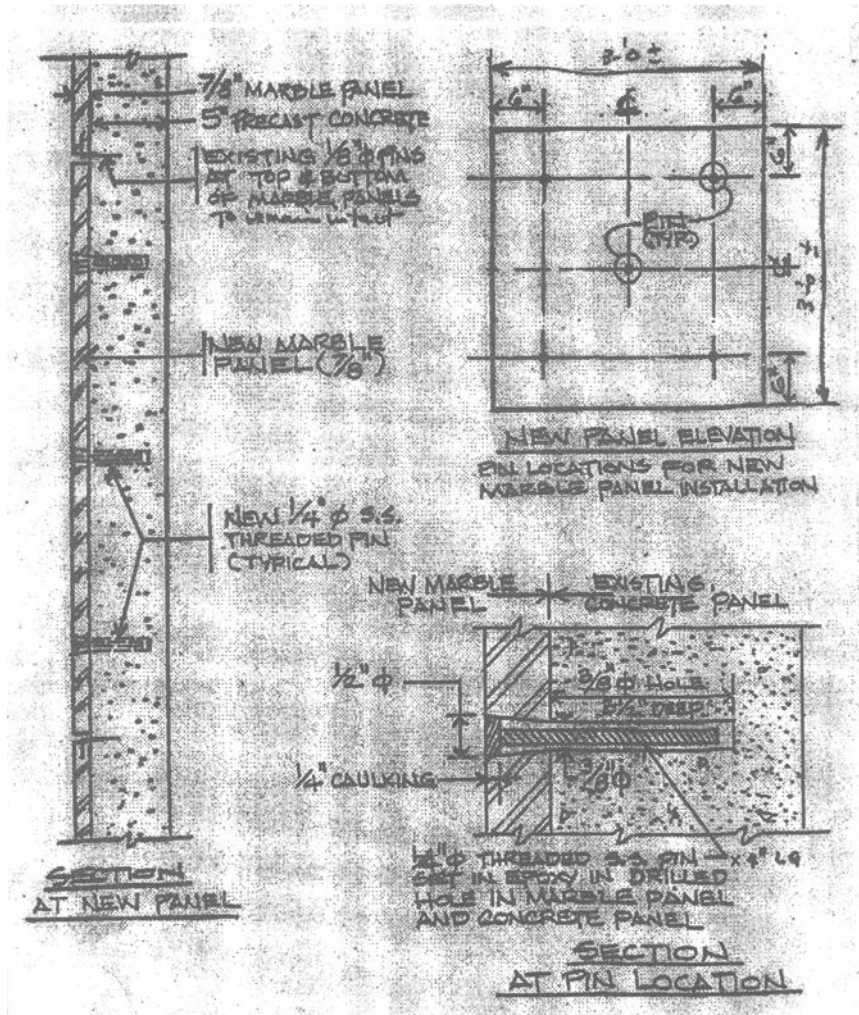
1. Bulged panels from 5/8 in. (1.5 cm) to 1 in. (2.5 cm): This condition was unsafe and required the complete replacement of these panels.
2. Bulged panels from 3/8 in. (1 cm) to 5/8 in. (1.5 cm): This condition required repairs, as noted.
3. Panels with bulges of less than 1/4 in. (6 mm) were judged to be acceptable. No repairs were needed at that time.

Refer to Figures 1 to 7 for selected photographs of the marble panel conditions, probing, and repair details.

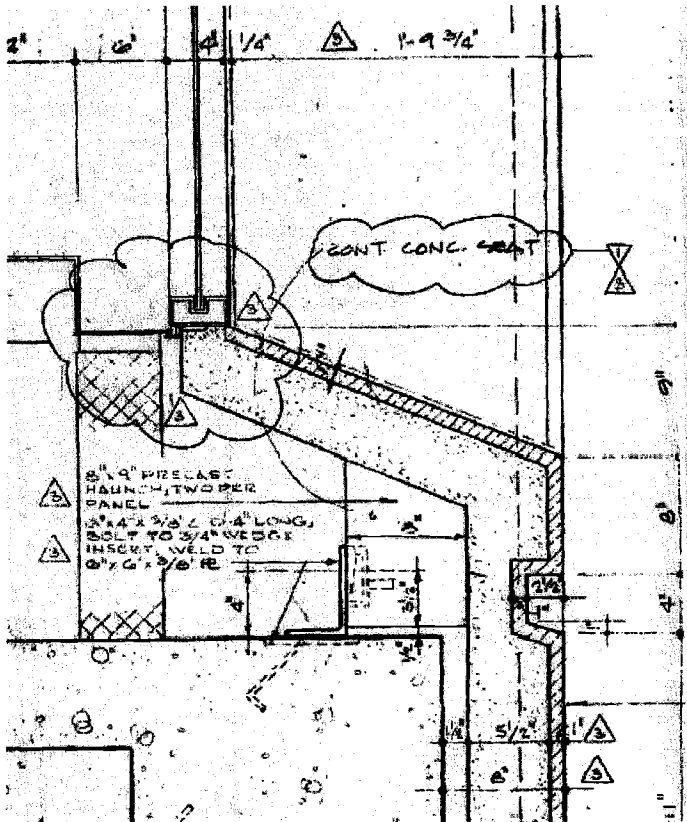
Figure 2 - Typical Existing Spandrel Condition

The facade is primarily composed of combination hairpin anchored and concrete-bonded travertine-faced precast concrete panels attached to the building frame perimeter spandrel beams, mechanically anchored travertine cladding to concrete frame perimeter columns, and discontinuous strip windows (Figure 2). Unfortunately, no project specifications, except those that existed on the drawings, nor as-built drawings, are available.

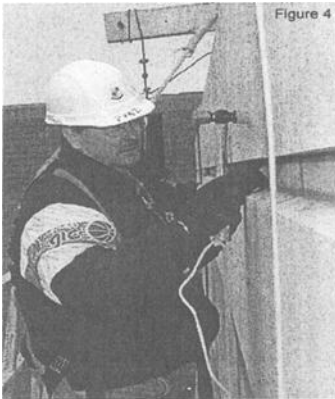
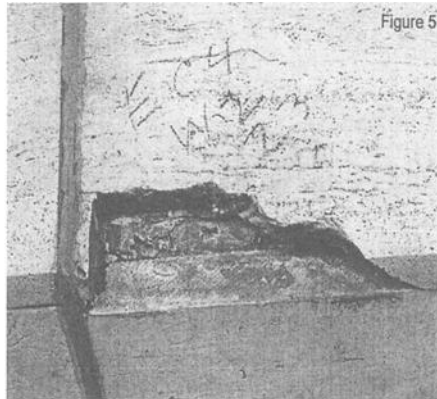
(Figure 4). Weathering of the travertine had resulted in etching and dulling of the stone surface. Many of the travertine voids had been filled with a cementitious material. Shadow lines were developing in the stone from obvious formation of calcite at cracks. Approximately 27% of the stone panels at the spandrel units were cracked. Other typical exposed stone cladding deficiencies were spalled edges (Figure 5), loose and missing stone, cracking at hairpin anchor locations, panel displacement at column covers, green algae and dust build-up in unfilled travertine voids, efflorescence, and iron staining.

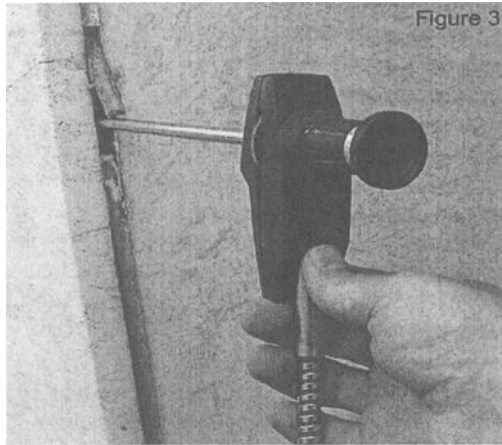
- [1] Cavity examination using an Olympus Borescope (Figure 3).

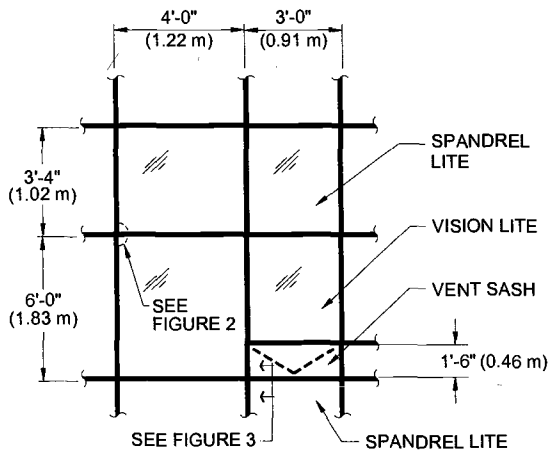
Figure 1 – Building One: representative area of façade

The curtainwall uses external aluminum retainers (pressure “plates”), secured by screws, on all four edges of each glass lite. Vision lites vary but most are about 3' (0.9 m) to 4' (1.2 m) wide by 6' (1.8 m) high. Figure 1 shows a typical vision and spandrel lite arrangement, with an inswing hopper type of vent window in one vision area. Log sheets, created by a repair contractor during preliminary repair attempts, recorded that, during their work, heads broke off of some of the screws that held the retainers. These breaks were detected as some retainers were removed and then replaced.

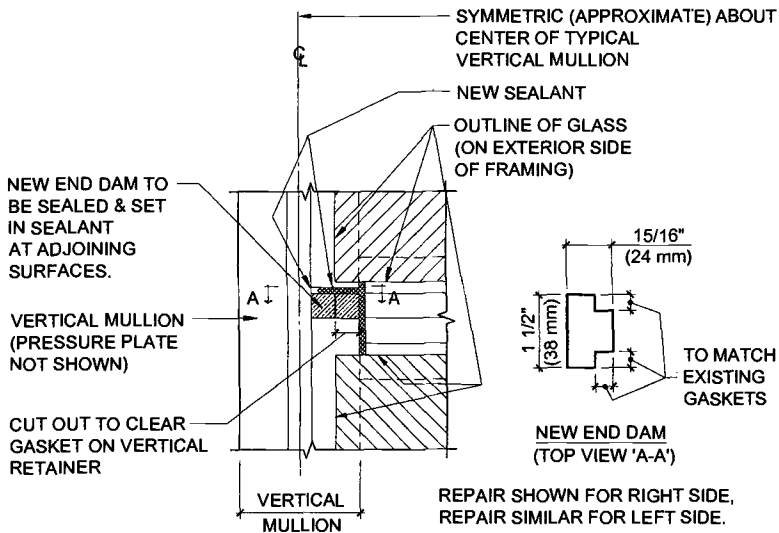
Figure 2 – Building One: end dam

size, shape, and quantity per glass lite. Some locations had setting blocks (rubber pieces, which support the glass weight) secured with sealant and no weep between setting blocks. Water could not flow past the blocks, which trapped the water in the central portion of the sill trough. The sill is the framing at the base of the glass lite. Water was not being drained rapidly enough from the sill cavity to avoid overflowing to the interior (e.g., pooling on exposed interior surfaces of the sills). For the test area, elongating the round holes to horizontal slots and adding a weep slot between setting blocks substantially reduced, to very little or to nothing, depending on location, the quantity of water which penetrated to the interior.

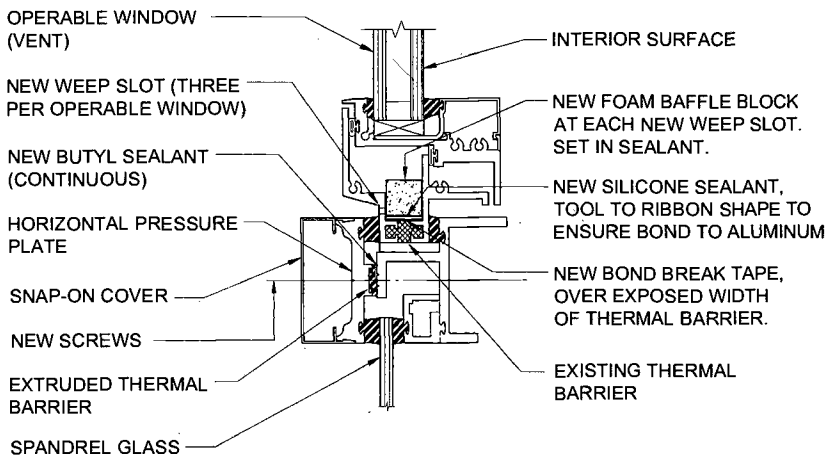
Figure 3 – Building One: section through horizontal members

Water testing was conducted at a one-story portion in the upper part of the façade. At the vision area, water testing was conducted both with and without an intentional air pressure difference. At the spandrel area, no intentional air pressure differential was imposed during the water test. Especially with an air pressure difference, the leaking prior to repairs was substantial. It was learned that drain holes (weepers) in the retainers were contributing to the uncontrolled water penetration because they were insufficient in

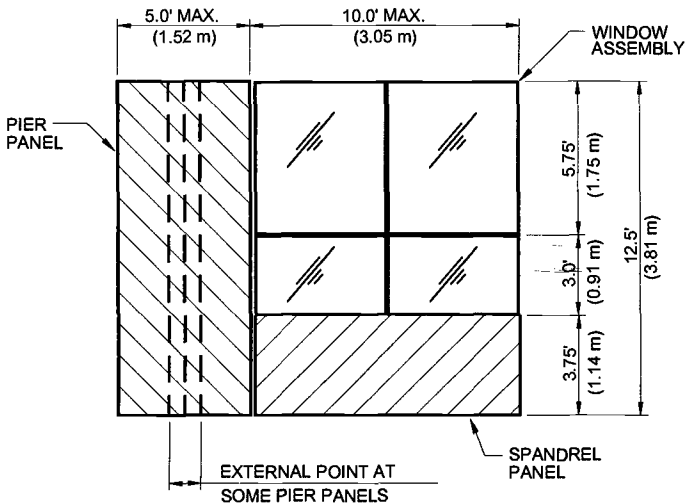
Figure 4 – *Building Two: panels and window*

The writer began his investigation in 1992. Water leaks had occurred in many areas of the façade. In addition, cracked mortar joints were observed at many locations that had a typical architectural feature, usually within a region extending several courses above the shelf angle. This feature, termed an external point, is a vertical strip of brick masonry, which is triangular in cross-section and protrudes from the wall (Figure 5). The writer’s firm was asked to assist in the façade investigation and design of structural repairs. The remediation project involved the services of two consulting firms. One firm, which was engaged first, was primarily concerned with addressing the water penetration aspects and issuing most of the construction documents for the remediation. The writer’s firm, engaged later, was primarily responsible for structural aspects of the investigation and repairs, and for most of the inspection program, which addressed water-

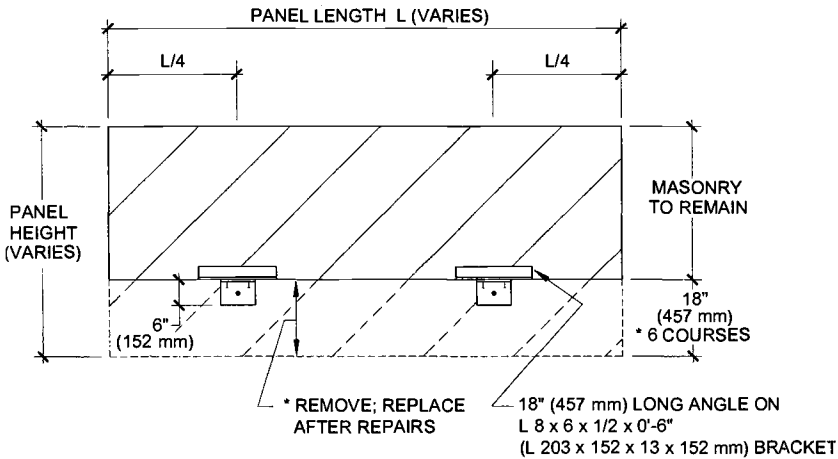
Figure 6 – Building Two: temporary support

The structural aspects included excessive torsional flexibility in the shelf angles, especially at the special portion (consisting of a welded, triangular horizontal plate with

welded vertical stiffener) used to support the “external point” feature. Many finite element analyses were made to evaluate both existing conditions and repair options. In addition, due to a dimension error on shop drawings, the shelf angles could not be properly positioned with respect to the cast-in-place inserts (with vertical slots) and subsequently mounted with the wedge-head bolts (Figure 7). The typical field modification made during original construction, to enable attaching the angles, was an enlargement (vertically and occasionally horizontally) of the horizontal slots in the

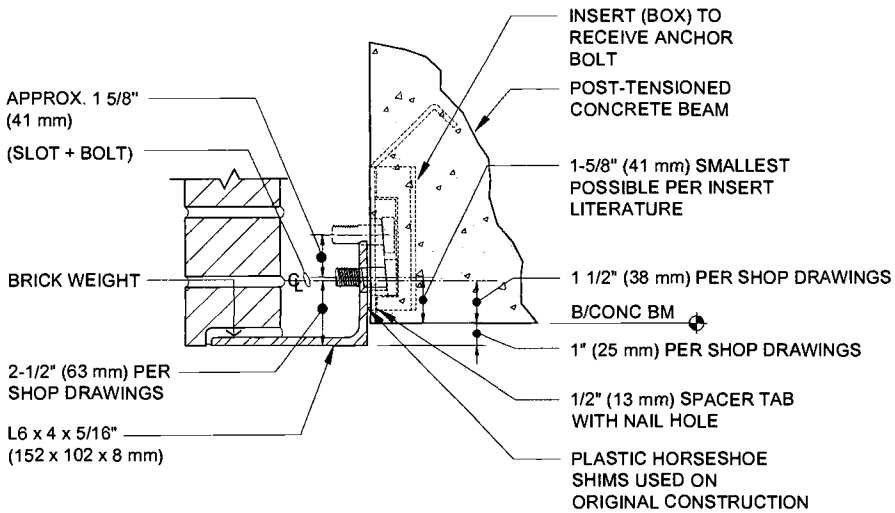
Figure 7 – Building Two: existing anchor (flashing not shown)

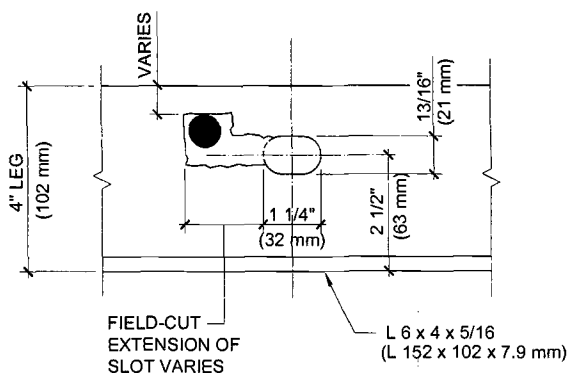
vertical leg of the shelf angle (Figure 8). The remaining net width of steel above the bolt was generally much less than in the original design. In some situations, the net width of steel above the anchor bolt was found to be insufficient.

Figure 8 – *Building Two: shelf angle at anchor slot*

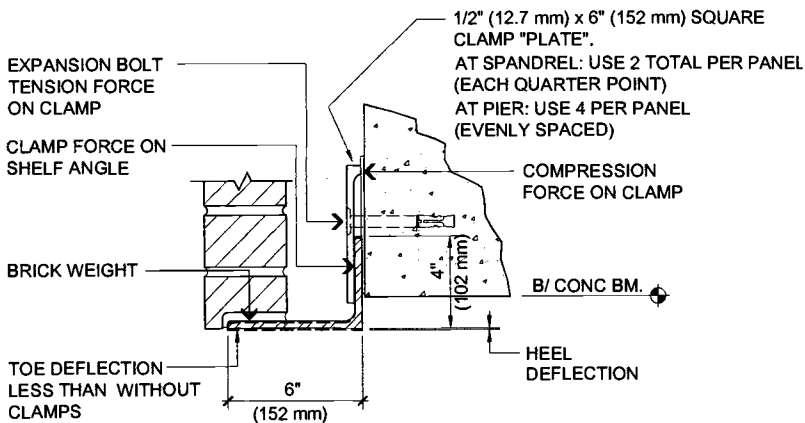
Figure 9 – Building Two: shelf angle plus clamp (flashing not shown)

- clamp “plates” (cut from angles) at appropriate spacing (further apart at spandrel panels and closer together at the pier panels) between existing anchors, with one anchor bolt per clamp plate, to reduce the torsional flexibility of the shelf angles by restraining the angle’s vertical leg (Figure 9);
- hanger “bars” (also cut from an angle), with an expansion anchor bolt into the concrete and an ordinary bolt into a tapped hole in the shelf angle’s vertical leg, at deficient slots and/or inadequately installed original anchors; and
- diagonal bracket (tension strap welded to a plate, and anchors), at each brick point, that was attached to the outer portion of the stiffener for the shelf angle’s triangular extension. The bracket’s top was connected to the concrete framing.

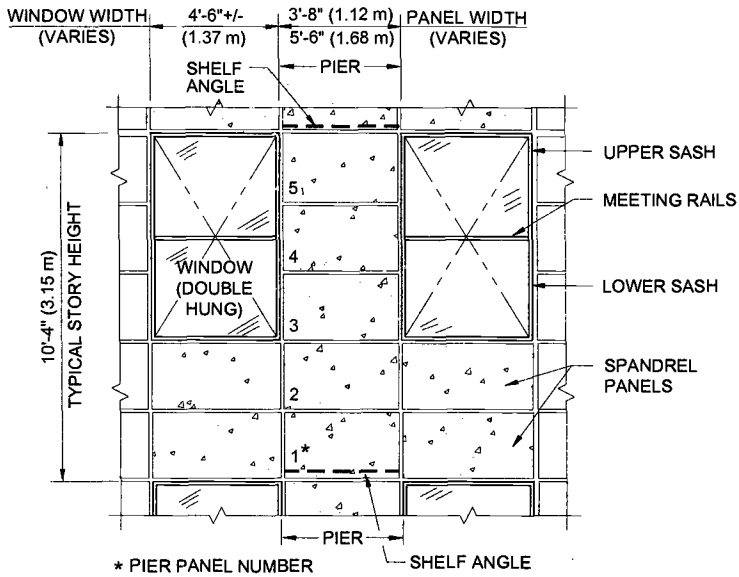
Four stone panels (all of the lowest three and most of a fourth) fell from a corner “pier” of the tenth story in the autumn of 2000. Fortunately, no one was injured. The entire street in front of the building was barricaded after the panels fell. These units hit a public sidewalk on a calm, sunny day. Each panel weighed, by calculation, between 500 and 600 pounds (2.2 and 2.7 kN). The writer observed two cracked portions of the top panel (unit #5 in Figure 11) hanging from a horizontal sealant joint. The cracks were essentially vertical and had been caulked at some time in the past. A remnant of panel #4 supported the third (corner) portion of panel #5 above. These pieces were pried loose by workers, using a wrecking bar while standing in the cage of a telescoping boom lift. The pieces were allowed to fall to the walk, because the pieces were too heavy to safely load into the lift.

Both drawings and building observations were used to investigate the accident’s cause. Observations revealed that the lower four of the typical stone panels were each secured by two steel strap (“zee” or “cee” shaped) anchors, at the top, to resist outward wind. These straps are 1/8" (3.2 mm) thick by 1 1/4" (32 mm) wide and were set in a clay-brick masonry back-up wall with the exterior ends fitted into kerfs (slots) in the stone. Some stone units had spalled at the anchor, either at the panel’s exterior side (observed at several locations away from the failure area) or at the panel’s interior side. Such an interior-side spall occurred in at least one of the failed stone units. Steel pins, 5/8" (16 mm) in diameter, had been used to secure the top edge of the top unit to the shelf

Figure 11 – Building Three: typical portion of façade

angle. Mortar was found at some locations between the bottom of the angle and the top of the stone below. This created a hard joint and it meant that axial (vertical) pressure could increase, with time, in the stone units as the shelf angles rusted and the rust tried to lift the bottom panel. Rust (iron oxide) has a volume that is about five to seven times the volume of the steel from which it is formed by oxidation. Rust has sufficient stiffness and strength to exert significant pressure. Substantial layers of rust were found on some of the angles. No flashings were found in the façade system.

This façade repair was primarily a structural fix, so that panels would be better supported. Thus, remediation efforts were intended to limit the shelf angle's vertical load in each story to the weight of that story's panels and to compensate for possible deficiencies in existing anchoring. Also, the repair program called for replacement of any shelf angles whose thickness had been reduced to below a calculated thickness limit.

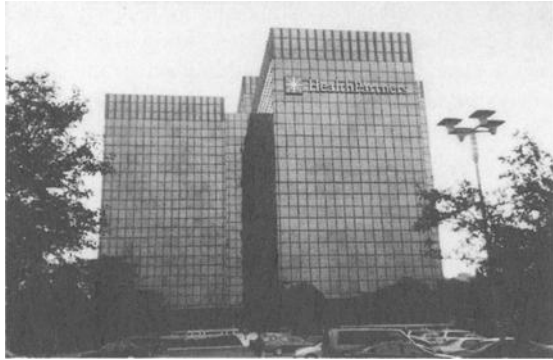
Pyrolytically applied reflective coatings are integral with the glass surface and resist color changes, but vapor deposited coatings on the #2 or #3 surface of IG units are vulnerable. (The four glass surfaces of a two-lite insulating glass unit are numbered from 1 to 4, starting with the surface exposed to the outside of the building). Changes in the color of reflected light produce facades that have a mottled appearance when viewed from a distance (Photo 2).

A mottled appearance can be an indication of moisture ingress into IG units because moisture in the unit can contribute to chemical changes in the reflective coating. A mottled appearance can also show the extent of glass replacement, since replaced units often do not match the original units in color. The mottled appearance of a reflective insulating glass facade is, therefore, cause for further investigation of the insulating glass units as discussed below.

Photo 2 – *Mottled appearance results from coating color changes*
