# **BUILDING** *FACADE* *MAINTENANCE, REPAIR,* *and INSPECTION*

STP 1444

# ***Building Façade Maintenance, Repair, and Inspection***

## Reporting Unsafe Conditions at Public Schools and Private Structures

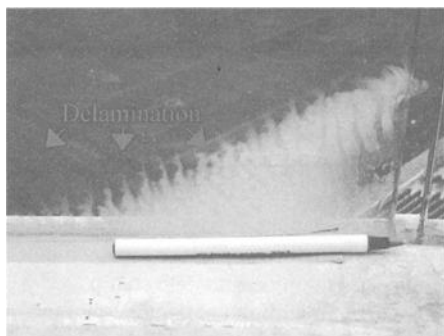
The plastic interlayer that bonds the sheets of glass together and retains the fracture fragments in the event of breakage will debond if the edge of the glass is subjected to certain chemicals or if the edge is exposed to prolonged water contact. The debonding generally appears as fingers emanating from the edge of the glass (Photo 4).

Photo 4 – Delamination of laminated glass handrail panel.

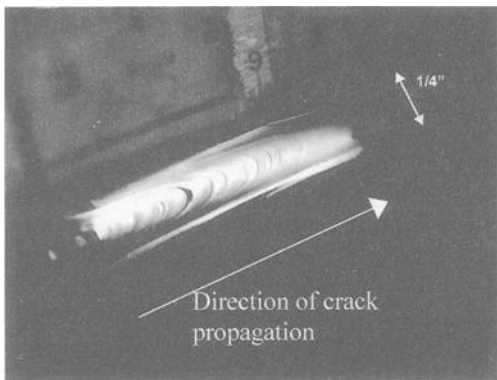
Propagating fractures in glass leave marks that describe the crack direction. These undulations in the fracture surface are concave toward the fracture origin (Photo 5).

Photo 5 – Rib marks show direction of crack.

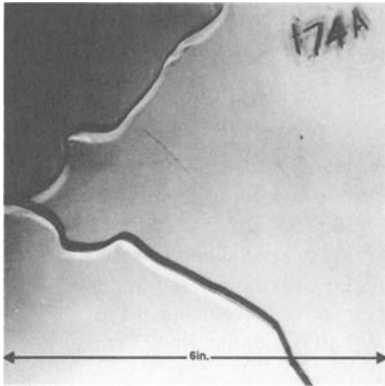
**Crack Orientation** – A crack that is perpendicular to both the glass edge and the glass surfaces is a thermal fracture that results from a temperature difference between the center and edge of the glass (Figure 1; Photo 6). Thermal stresses resulting from a center-to-edge temperature difference are nearly uniform across the thickness of the glass and create tension along the glass edge. Since cracks run perpendicular to the principle stress direction, the cracks are perpendicular to the edge and surfaces of the glass.

Photo 6 – Thermal Crack Pattern.

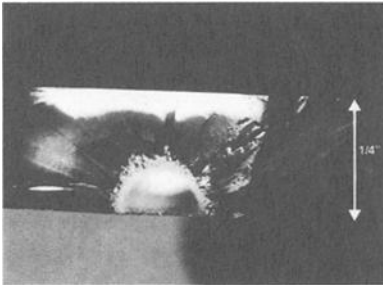
The shape of the mirror describes the type of stress. Thermal stress mirrors (Photo 7) are generally fully enclosed by mist and hackle due to the uniformity of the tensile stress across the thickness of the glass. Bending stress mirrors (Photo 8) are open toward the

Photo 7 – Fracture origin resulting from thermal stress.

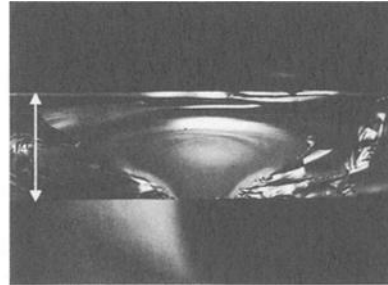
mid-plane of the glass because the tensile stress is highest at the surface and diminishes to zero at the neutral plane in the middle of the glass thickness.

Photo 8 – Fracture origin resulting from bending stress.

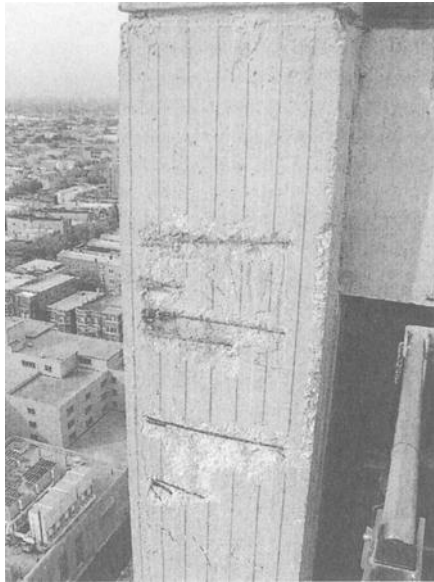
FIG. 2 - *Example of concrete spalling distress in a building column.*

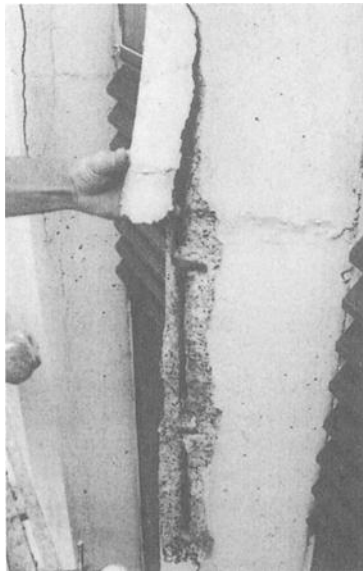
FIG. 3 - *Example of severe concrete spalling and cracking distress at a building column*

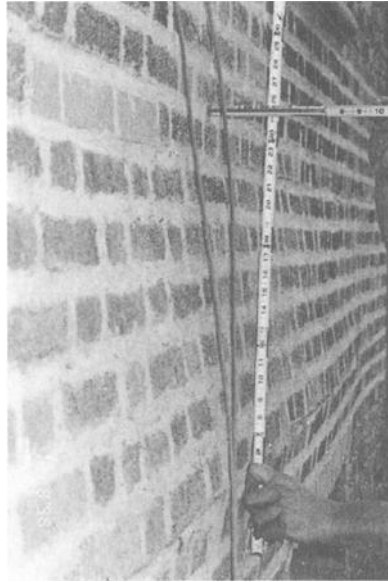
Figure 2

- Bulging and lateral movement of masonry, resulting in partially or fully unsupported conditions and/or loss of material (Figures 2 and 3);
- Cracking, spalling, and loss of architectural elements due to freeze-thaw cycling and corrosion of embedded anchors and steel framing (Figures 4 and 5); and
- Increased water penetration resulting in accelerated damage and loss of material.

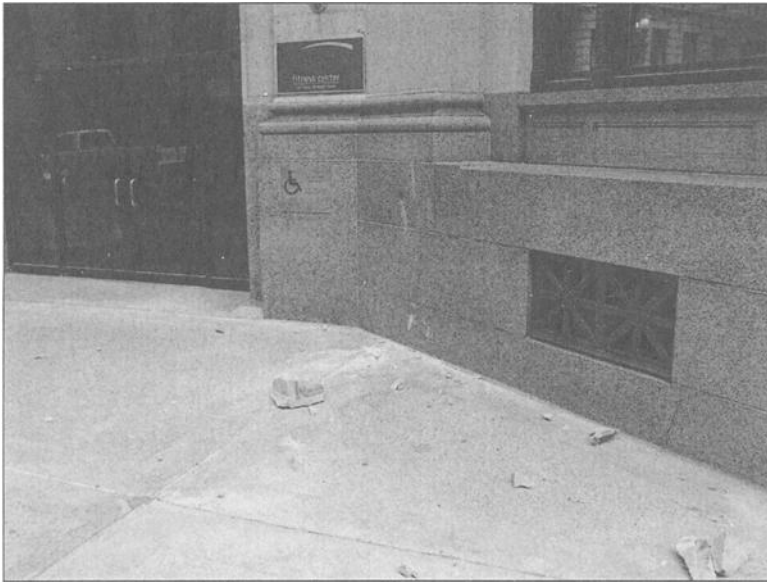
Figure 10

- Inspect all Facade Surfaces: The Chicago, IL, ordinance is the only one that requires that the hands-on inspection to be on all facade surfaces. On the other extreme, Detroit, MI, only requires the inspection of cornices or similar projections that are subject to deterioration or corrosion. The other three ordinances fall somewhere in between. Like the Chicago ordinance, we recommend that building owners have a hands-on survey conducted on all facade surfaces. This need is illustrated by a recent event in a large city in the northeastern United States. At 11:00 a.m. on a weekday, a large limestone modillion weighing approximately 100 lbs (Figure 10) fell 16 stories onto the sidewalk adjacent to the main entrance of the building. Fortunately, nobody was injured. The building owner had the facade inspected by a professional engineer two years prior. The ordinance in this city only requires one inspection drop on all elevations of the building. The report submitted to the city complied with the ordinance. The inspection drops were not made in the area of the fallen modillion.

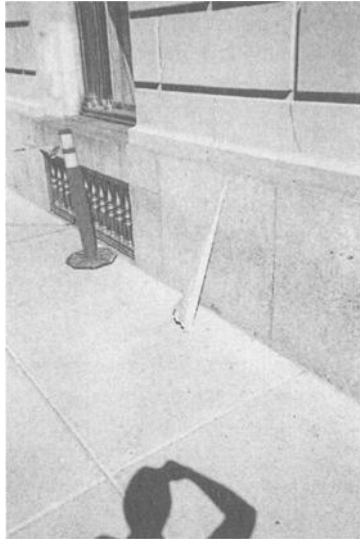
Figure 11

- Removing unstable elements (Figure 11);

Broken or deteriorated elements that are hazardous should be removed from the building and replaced or reattached (see below). Large pieces can be removed and stored for reinstallation if historic renovation is required. During inspections, patches, cracks, and suspected spalls should be sounded with masonry tools. If areas sound hollow, they should be probed and removed as required. An easy determination of whether a spall should be removed is to “wiggle” the spall. If the spall wiggles under hand pressure, it should be removed.

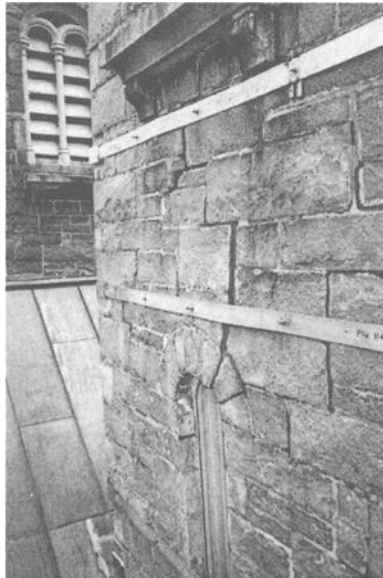
Figure 12

- Repairs to stop water intrusion; and
- Retaining elements in place, generally with pins, straps, or netting (Figures 12 and 13).

While removing loose pieces may be a relatively simple and quick method of reducing the risks of falling objects, it generally means more extensive restoration is needed in the future, particularly if decorative elements are removed. An alternative is to retain pieces in place. Retaining elements in place is often done using a combination of epoxy-set or mechanical anchors, external metal straps, hardware cloth, or polypropylene netting. These methods can temporarily secure historic fabric and maintain a semblance of the facade’s appearance until final repairs are implemented. However, temporary pins and nets must be monitored on a continuing basis and augmented, if required, until permanent repairs are completed.

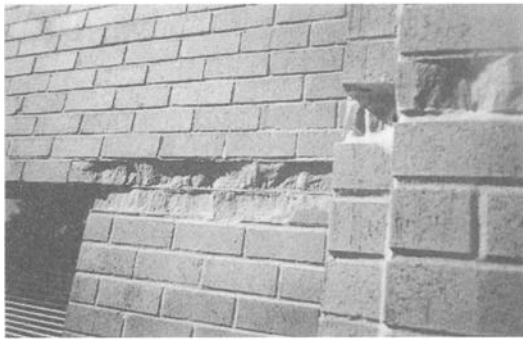
➤ Emergency stabilization: visual inspection from the ground level revealed spalling brick along relief angle lines (Figure 3). We knew that once we got on the facade, it made the most sense to do some level of stabilization (removal, temporary patching), thus this was factored into our contract.

Figure 3 – *Spalling brick along relief angle line.*

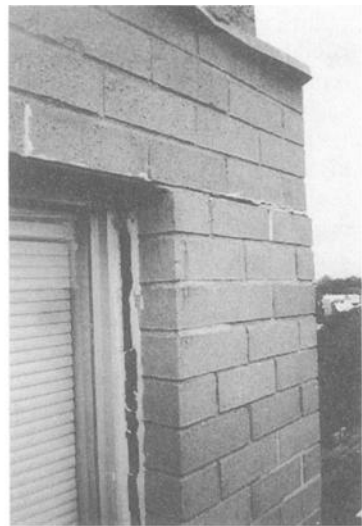
- Hidden conditions: while we could see from grade the need to stabilize spalling masonry, we expected to encounter other areas requiring stabilization repair that were not discernable from grade level. An example is bulging regions of masonry resulting from rust jacking, especially at the roof level (Figure 4).
- Locations of swing scaffold drops: we wanted to cover the range of conditions on each façade and look at similar wall configurations over different exposures, but this was tempered by the desire to access visibly distressed areas to perform stabilization measures.
- Game plan: it is common to start out with a set plan on how to proceed around the building (number of swing drops, number of moves), but often the plan must be modified after a few drops, once we understand more fully the conditions we are encountering and their meaning, to correspondingly redirect the survey focus.

Figure 4 – *Rust-jacking induced bulging at window corner.*

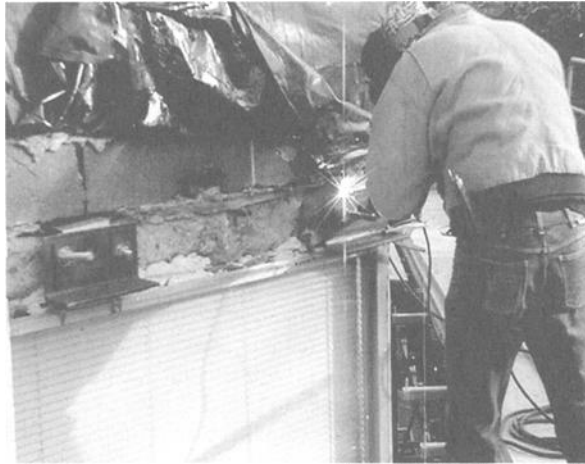
- Zoning issues became apparent during permitting, due to the introduction of endwall windows – the north face of the building was located at the property line setback limit, thus the window extensions encroached on the setback;
- Selective probing and removals along bay regions to take field measurements for pilot windows failed to detect significant variation in slab edge locations over the height of the building; only after the windows were ordered and we had begun formal demolition did we realize that the slabs on one side of the bay had been crudely cut back beyond the face of the relief angle, while on the other side, upwards of 2" of shims had been added behind relief angles (Figure 7).

*Figure 7 – Variation in Slab Edge Locations*

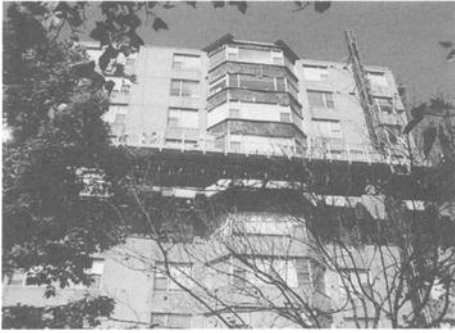
Figure 8 – *Bay Demolition Proceeded Top to Bottom*

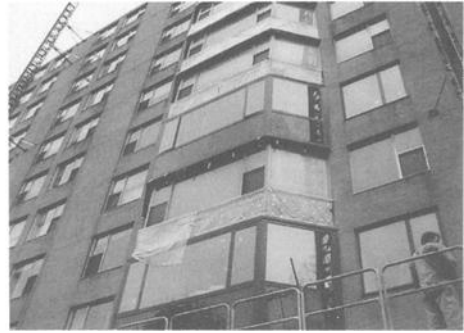
Figure 9 – *Reconstruction Proceeded Bottom to Top*

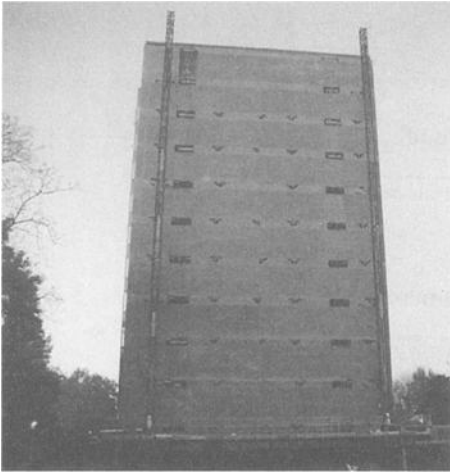
Figure 10 – *Endwall window sequencing.*

Work progressed rapidly, but a major improvement aspect remained to be fully defined – installing new windows in the blank endwalls. Through collaboration with the SRC, we had developed a scheme that minimized the number of separate mast platform drops, with resultant time and cost savings, while minimizing initial wall removal and limiting the vulnerability of the building to leakage during this period. The initial pass removed only enough masonry to install and cast the cantilevered slabs edges (Figures 10 & 11). Once the slabs had all been cast, we worked from bottom to top, removing the balance of the masonry, installing temporary protection, following with the new curtainwall installation on a floor by floor basis. Turn-around time for interference inside residential units was limited to three days, as with the bay window replacements.

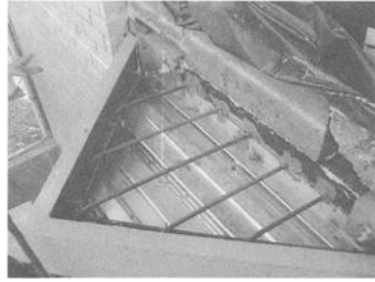
Figure 11 – *Cantilevered slab extension at new endwall windows.*

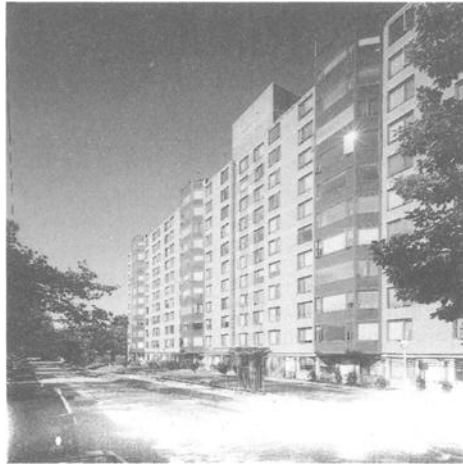
Figure 13 – *Completed Façade*

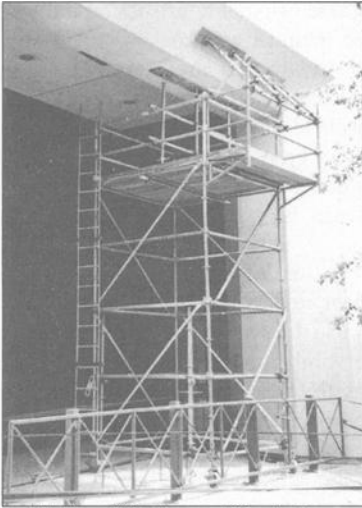
A. Installation of Shoring and Barricades

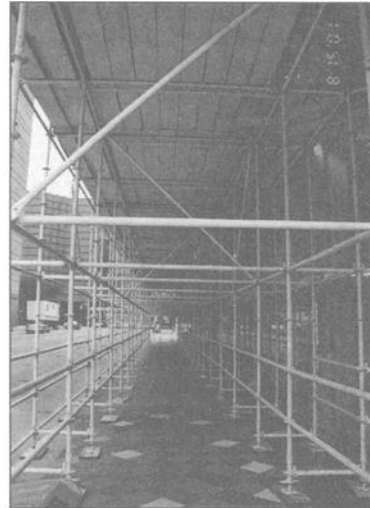
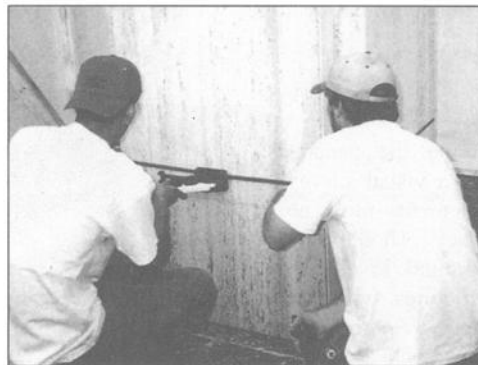
B. Installation of Overhead Protection

C. Panel Strapping

*Figure 1 - Precautionary measures installed as a means of temporary protection from the potential falling of unstable stone cladding portions. Examples shown include (A) installation of shoring and barricades, (B) installation of overhead protection and (C) panel strapping stabilization.*

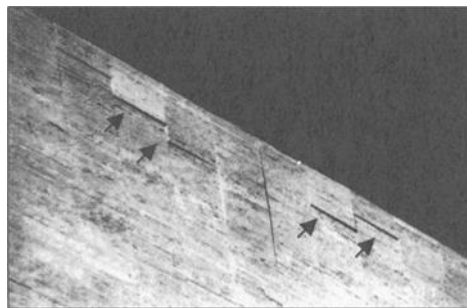
*Figure 2 - Observations at stone facade locations where displacement is visible under tangential daylight when observed from an angle to the building face.*

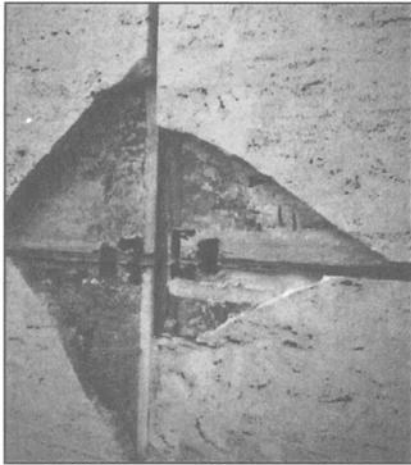
A. Spalled stone at ferrous embeds

**Figure 3 - Examples of typical stone distress including (A) spalled travertine stone panel corners at ferrous chairs within concrete panel, (B) displaced travertine stone panels as a result of corrosion of backup, (C) cracked travertine stone panel due to expansion of soffit steel framing, and (D) bowing and cupping of marble stone panels.**

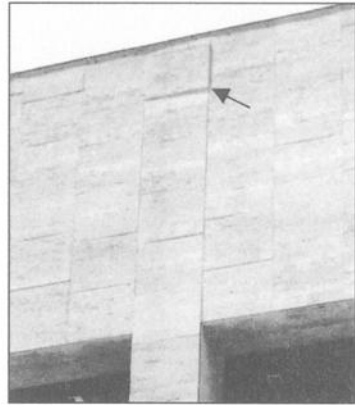
B. Displaced stone, later removed as a precaution and selected for investigative opening

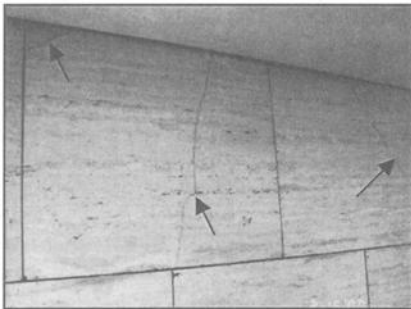
C. Cracked stone due to soffit framing expansion

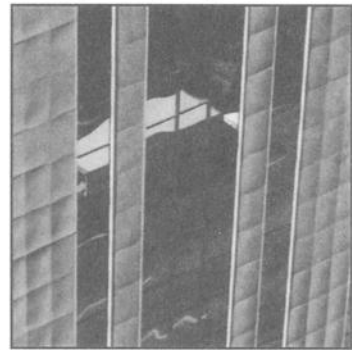
D. Cupped and bowed stone panels

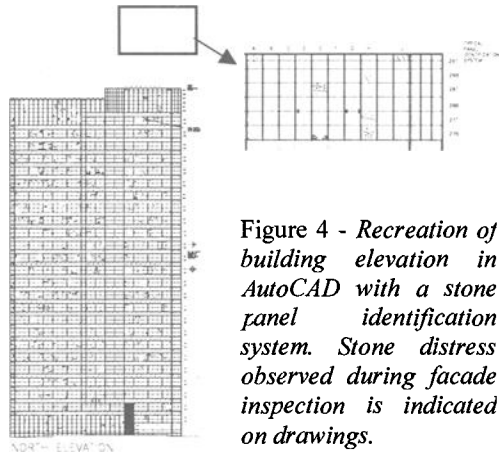
Figure 4 - Recreation of building elevation in AutoCAD with a stone panel identification system. Stone distress observed during facade inspection is indicated on drawings.

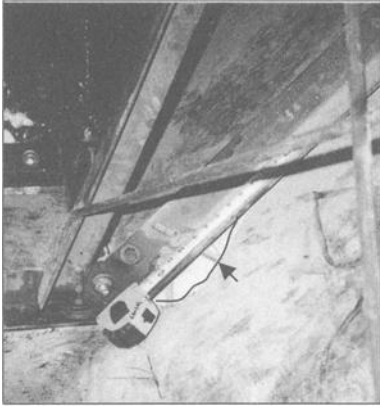
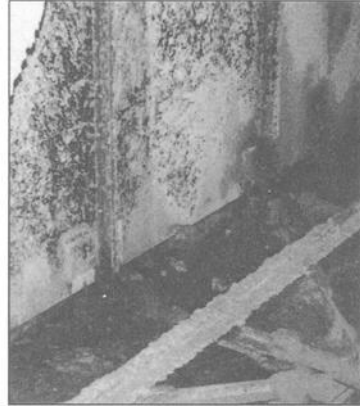
connections and the backup material(s) are acceptable. As Figure 5 illustrates, spalls may be present on the interior side of the stone panels or the backup material may be severely deteriorated. These conditions are not visible during the visual survey or up-close survey; therefore, inspection openings, probing, or interior observations are necessary to confirm the condition of the cladding backup and connections.

Figure 5 - *Spall on interior side of stone panel at panel connection and corrosion of backup observed during survey of the interior side of the stone panels.*

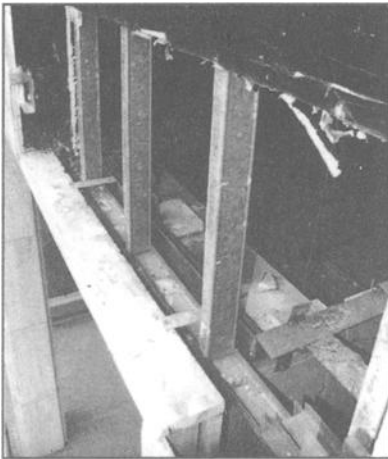
A. Structural steel and stud wall backup

Figure 6 - *Inspection openings for observations of backup and connection conditions.*

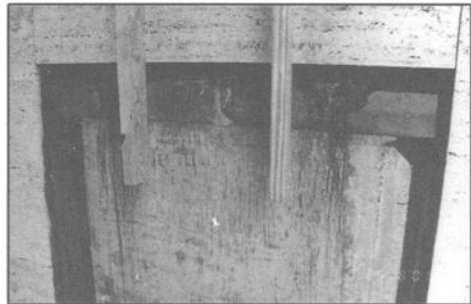
B. Corrosion of backup that resulted in stone panel displacement shown in Figure 3C

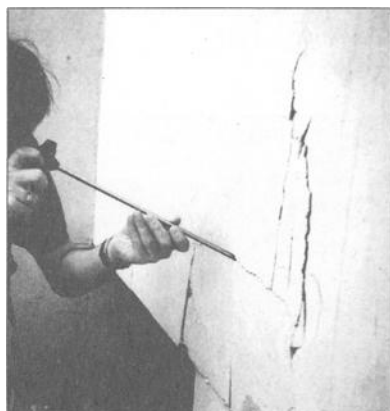
Figure 7 - Use of a borescope at a distressed limestone facade panel

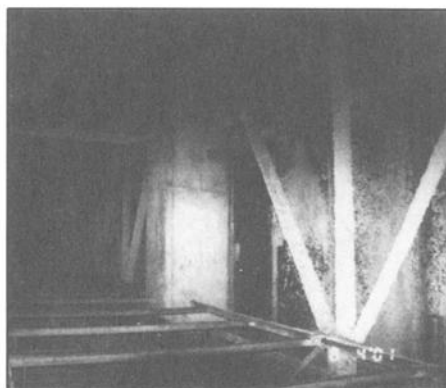
Figure 8 - Interior observations of truss-supported thin-cladding system

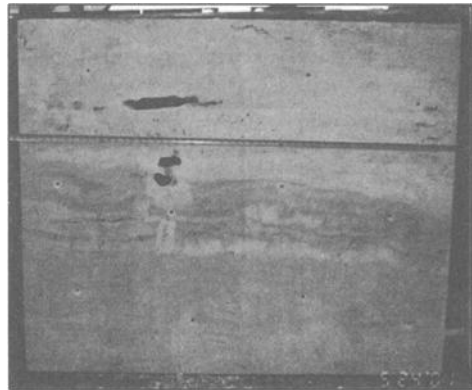
Figure 9 - Excessive veining and voids within a travertine stone panel.

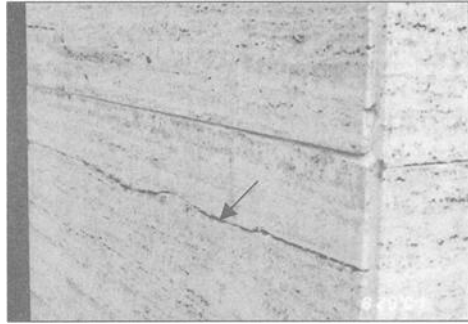
Figure 10 - Crack distress observed within natural vein of stone.

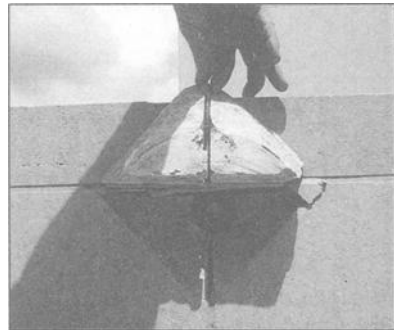
Figure 11 - Spalled limestone panel corners at ferrous washer

1. Ferrous or dissimilar metals used for stone connections, which corrode and deteriorate in the presence of water. This condition may lead to spalling of stone or failure of stone connection, as shown in Figure 11.

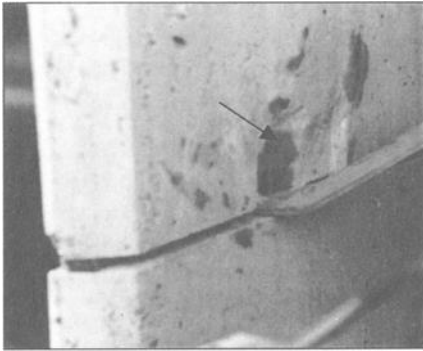
A. Spalled epoxy-filled pin connection

Figure 12 - Failed epoxy and wire-tie stone panel connections.

2. Non-durable connection materials that are not suitable for severe exterior exposure like interior-grade epoxy and non-copper or non-stainless steel wire-tie connections. These materials can deteriorate over time when exposed to exterior environmental conditions or may melt in the event of a fire. Figure 12 illustrates failed epoxy and wire-tie stone panel connection locations.

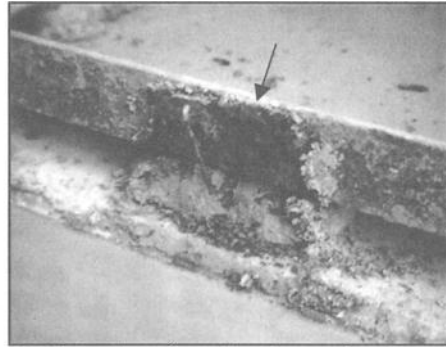
B. Corrosion of steel backup and embrittled wire-tie connection

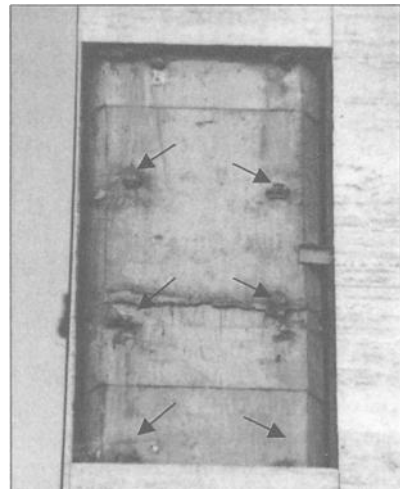
Figure 13 - Location of panel collapse where blind mortar spot with wire-tie connections deteriorated and failed.

part of initial improper installation. Figure 13 illustrates the use of a blind mortar spot with wire-tie connections where both the wire-tie and gypsum based mortar have deteriorated and failed resulting in the collapse of the stone panels.

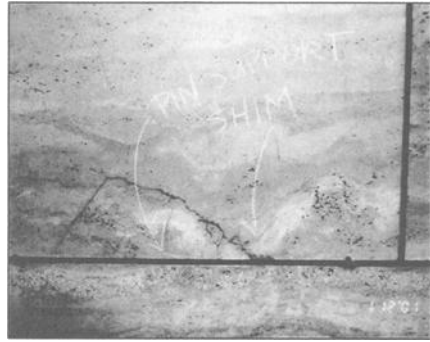
Figure 14 - *Distress in stacked travertine panel at shim support*

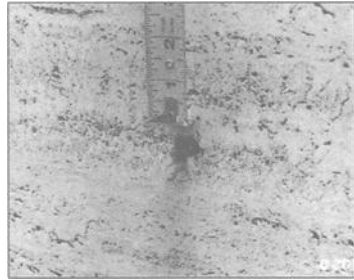
Repairs may be performed as a part of the building's exterior maintenance. However, sometimes these "repairs", if unsuitable, may create more problems for the natural stone cladding. Allowing the passage of water and vapor from the natural stone facade is important. However, some "repairs" include the use of vapor impermeable materials that can potentially lead to stone distress. For instance, the use of vapor-impermeable coatings or hard, vapor-impermeable mortars forces moisture and salts within the exterior wall system to become trapped within or pass through the stone panels [5]. The salt then crystallizes within or on the surface of the panels, resulting in distress. In some instances, ferrous repair materials like the supplemental through-stone anchors shown in Figure 15 may have been used. As the ferrous anchors corrode and expand, they create additional distress in the stone panels they were intended to repair.

Figure 15 - *Ferrous through-stone repair anchor*

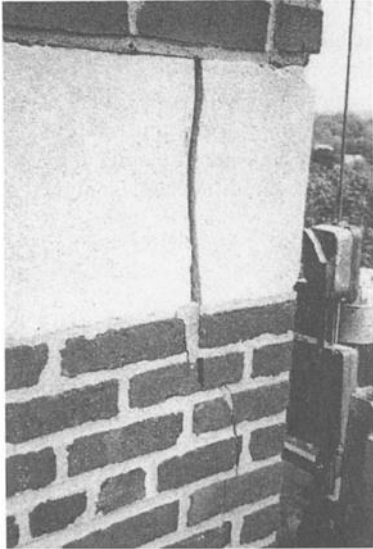
*Figure 1 - Cracked and displaced masonry*

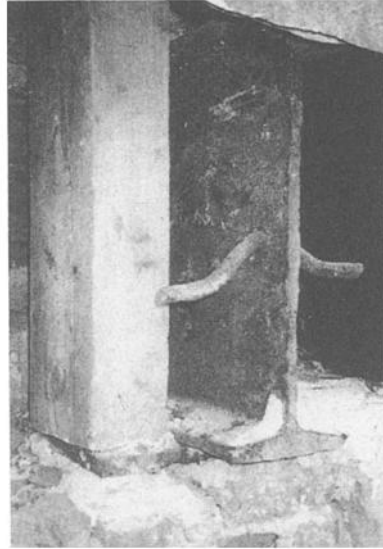
*Figure 2 - This corroding steel beam was found when the masonry in Figure 1 was removed.*

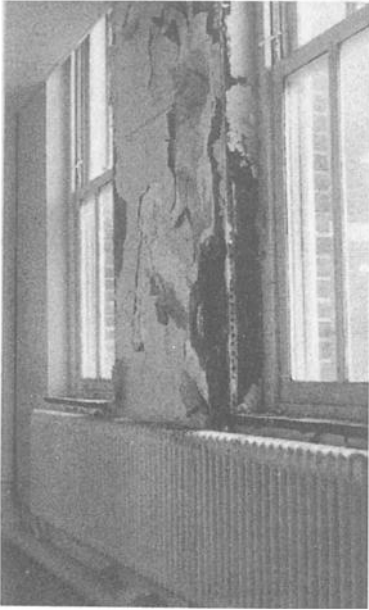
*Figure 3 - Severe interior damage from water leakage*

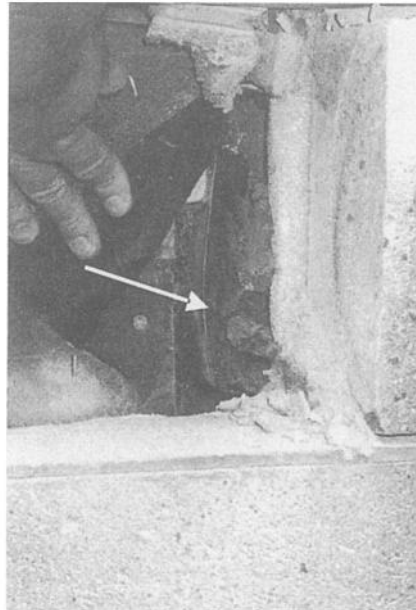
*Figure 4 - Unsealed flashing at corner. Arrow indicates open end of metal flashing. Also note mortar blockage.*
